PIC32MZ EF FAMILY

PIC32MZ Embedded Connectivity with Floating Point Unit (EF) Family Silicon Errata and Data Sheet Clarification

The PIC32MZ Embedded Connectivity with Floating Point Unit (EF) family of devices that you have received conform functionally to the current Device Data Sheet (DS60001320), except for the anomalies described in this document.

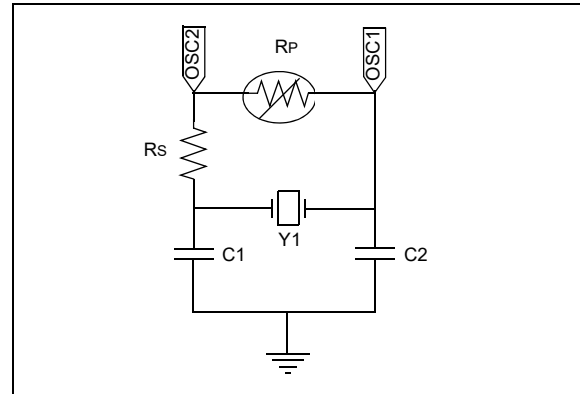
FIGURE 1: Posc CRYSTAL CIRCUIT

Revision A1 Silicon: A crystal oscillator cannot be used as an input to the Primary Oscillator (Posc) pins OSC1 and OSC2.

Revision A3 and B3 Silicon: The POSC has been tested in a normal power-up sequence and supports specific crystal operation.

The Primary Oscillator (Posc) has been characterized to operate at 8 MHz, 12 MHz, and 24 MHz when the circuit in [Figure 1](#) is implemented, and the operating conditions listed in [Table 3](#) are met.

Crystal Frequency (see Note 1)	Series Resistor (Rs)	Posc Gain Setting POSCGAIN<1:0> (DEVCFG0<20:19>)	Posc Boost Setting POSCBOOST (DEVCFG0<21>)
8 MHz	2 kΩ	'0b00 (GAIN_0)	'0b1 (ON)
12 MHz	1 kΩ	'0b00 (GAIN_0)	'0b1 (ON)
24 MHz	0 kΩ	'0b00 (GAIN_0)	'0b1 (ON)

- Note 1:** Using any other crystal frequency will require special component selection and characterization.
Note 2: A parallel resistor (Rp) should not be used to increase the gain of the POSC.

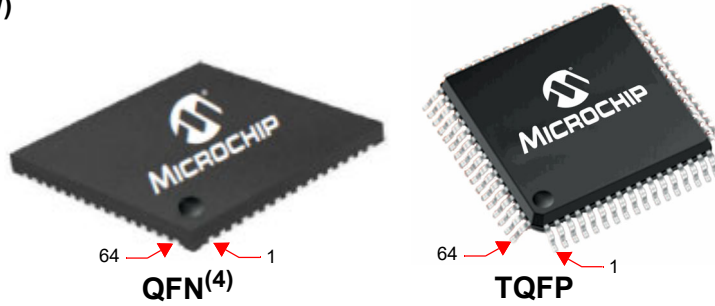
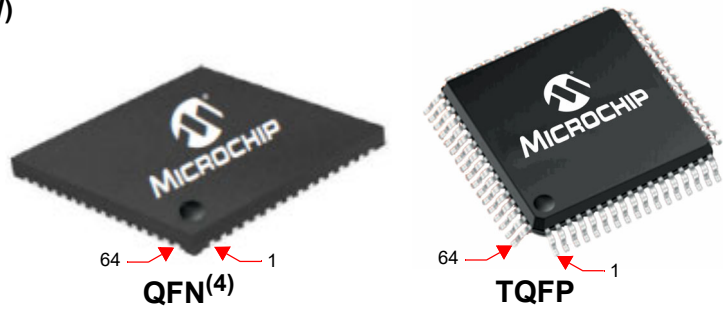
64-PIN QFN⁽⁴⁾ AND TQFP (TOP VIEW)

The following typographic corrections and clarifications are to be noted for the latest version of the device data sheet (DS60001320H):
