# PIC32MZ EF FAMILY

## PIC32MZ Embedded Connectivity with Floating Point Unit (EF) Family Silicon Errata and Data Sheet Clarification

The PIC32MZ Embedded Connectivity with Floating Point Unit (EF) family of devices that you have received conform functionally to the current Device Data Sheet (DS60001320), except for the anomalies described in this document.

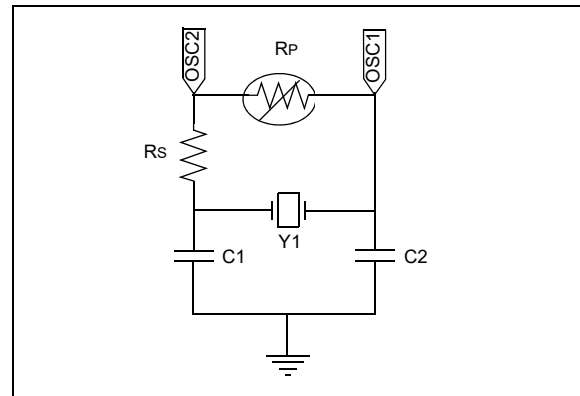
**FIGURE 1: Posc CRYSTAL CIRCUIT**

**Revision A3 and B3 Silicon:** The POSC has been tested in a normal power-up sequence and supports specific crystal operation.

The Primary Oscillator (Posc) has been characterized to operate at 8 MHz, 12 MHz, and 24 MHz when the circuit in [Figure 1](#) is implemented, and the operating conditions listed in [Table 3](#) are met.

- Note 1:** Using any other crystal frequency will require special component selection and characterization.  
**Note 2:** A parallel resistor (Rp) should not be used to increase the gain of the POSC.
