**3 Volt Intel[®] Advanced Boot
Block Flash Memory
28F004/400/008/800/
016/160/320/640B3 (x8/x16)**

Specification Update

April 2002

Order Number: 297948-012

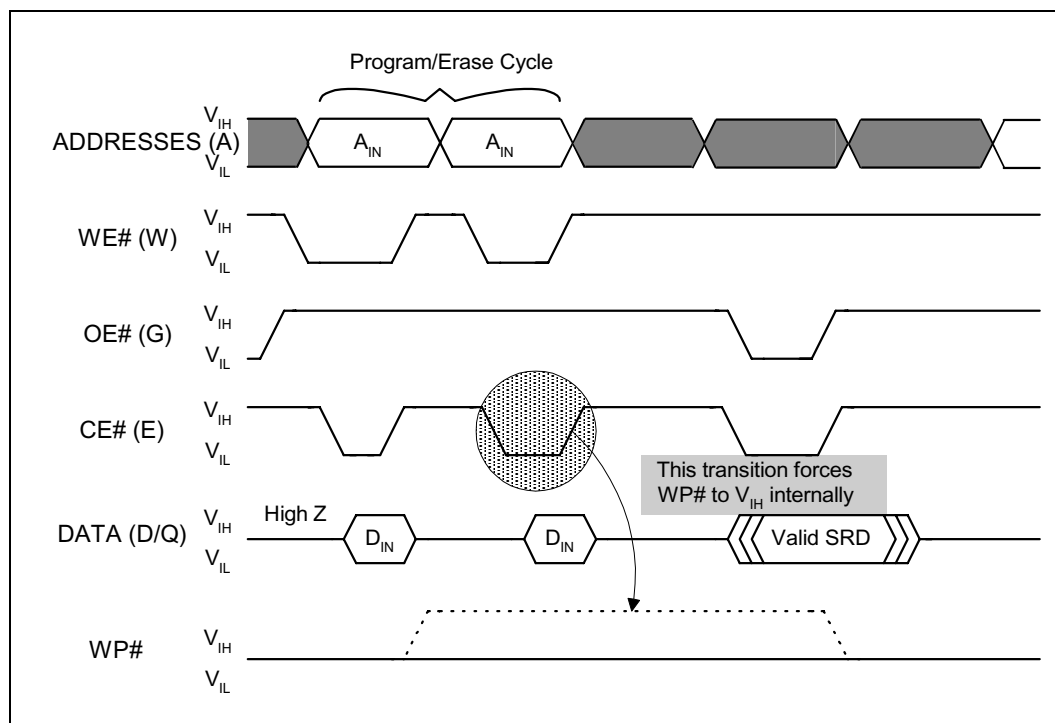
1. Block Locking during Write Operations If CE# Is Toggled High

In normal operation, $WP\# = V_{IL}$ locks the upper two (or lower two, in the case of a bottom boot device) parameter blocks. If a program or erase command is issued to a locked block, the WSM sets the program or erase status bit and the block lock status bit to “1” and prevents the program or erase operation to the locked block.

However, initial samples of the 28F160B3 flash memory device ignore the $WP\#$ pin if $CE\#$ is toggled high during the second cycle of a program or erase operation. Any program and/or erase commands issued to locked blocks **may change** memory contents even if $WP\# = V_{IL}$ (assuming $V_{PP} > V_{PPLK}$).

Implication: This erratum causes the lockable blocks to be unlocked regardless of the state of $WP\#$ when $CE\#$ is toggled high during the write cycle(s).

Workaround: Applications using A-0 material should hold $CE\#$ low and toggle $WE\#$ to latch command, address, and data during a program or erase operation.

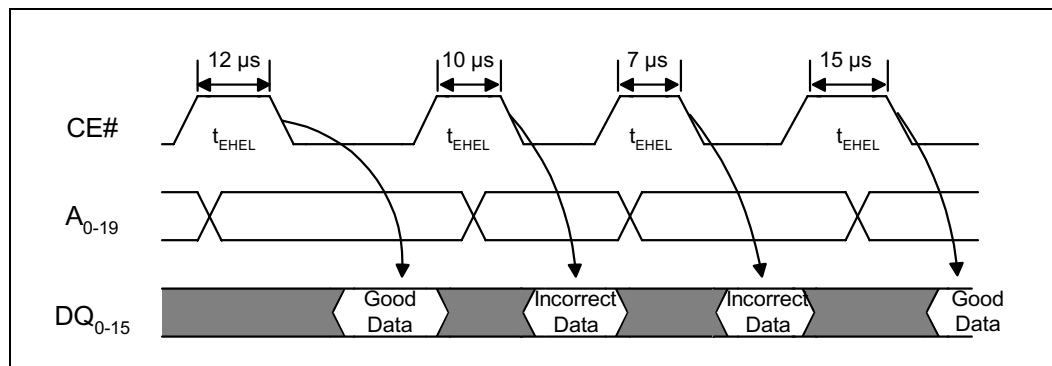
2. Invalid Read Durations for CE# High Pulse Width

Problem: During consecutive read operations, CE# may be left low or toggled as desired. If CE# is toggled high (see diagram below) for 4 μs –11 μs between read operations, subsequent reads will return incorrect data.

Implication: If CE# is not toggled between consecutive reads, there is no impact. Any application that toggles CE# between read operations will be affected if the CE# high pulse width is within the nonfunctional range, i.e., 4 μs \leq t_{EHEL} \leq 11 μs .

Workaround: Either of the following actions will prevent this erratum:

1. Do not toggle CE# between consecutive read operations
2. Insure t_{EHEL} is less than 4 μs or greater than 11 μs

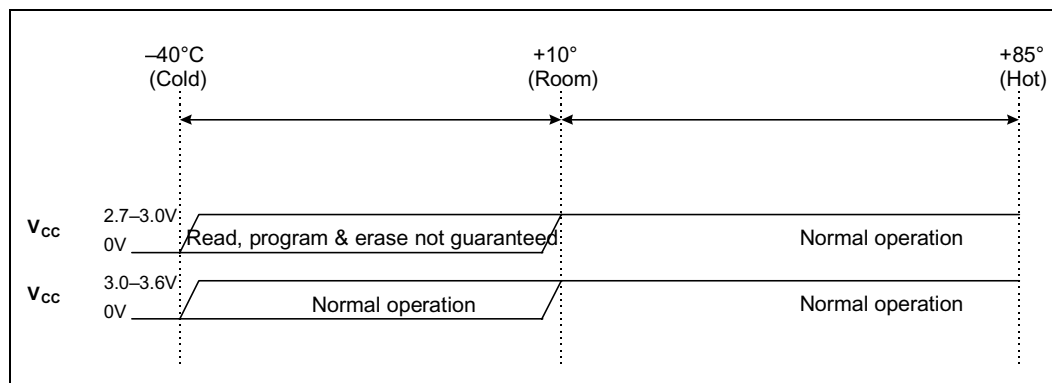
3. Temperature Effect on V_{CC} Ramp

Problem: The 28F160B3 flash memory operates from 2.7 V–3.6 V across the full extended temperature range (–40 °C to +85 °C). For a limited number of 28F160B3 engineering samples, when ramping V_{CC} to below 3.0 V and below +10 °C (–40 °C to +10 °C), the device is not guaranteed to respond to read, program, and erase operations (see diagram below). If V_{CC} ramps to a value between 3.0 V and 3.6 V, the device functions normally across the entire extended temperature range.

Implication: If V_{CC} is ramped to [and maintained at] a level below 3 V between –40 °C and +10 °C, the device may not function properly.

Workaround: Either of the following actions will prevent this erratum:

1. Ramp V_{CC} above 3.0 V in order to trip the V_{CC} detector; once the detector has “tripped,” the voltage may be lowered below 3.0 V for normal operation
2. Only ramp V_{CC} at temperatures above +10 °C.

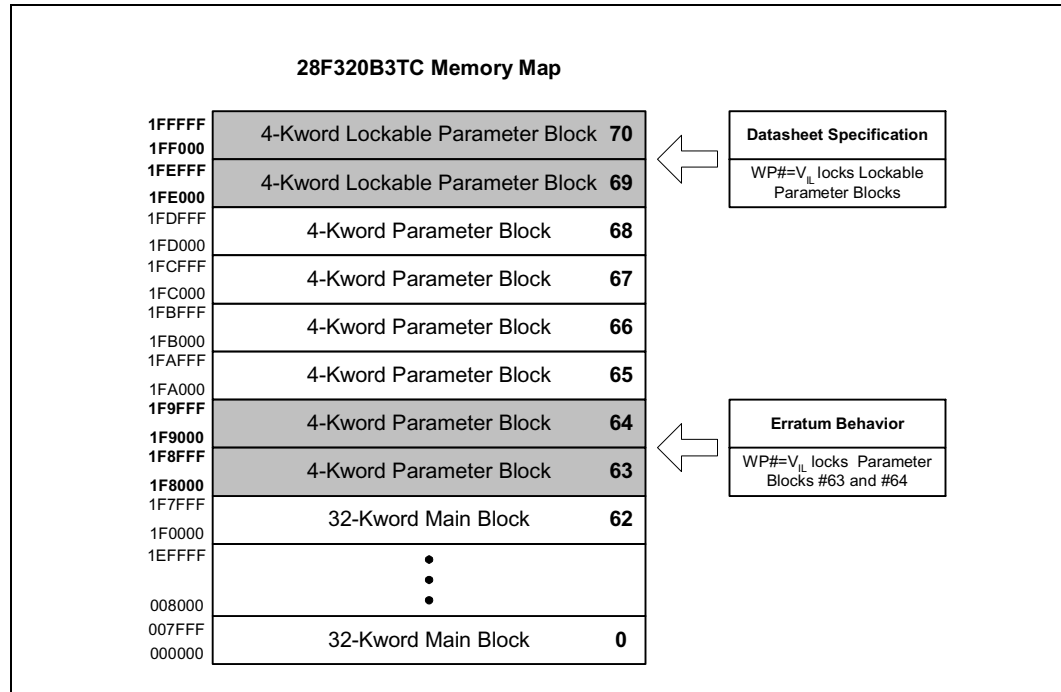
6. 28F320B3TC Block Locking Failure

Problem: For the 0.18µm 32 M-bit top boot devices affected by this erratum, block locking functionality deviates from the datasheet specification. WP#=V_{IL} protects blocks #63 and #64, instead of blocks #69 and #70).

Implication: There are two implications to this erratum:

- 1) The two Lockable Parameter Blocks (blocks #69 and #70) are not protected when WP#=V_{IL}; and
- 2) When WP#=V_{IL}, blocks #63 and #64 will be locked, and any attempts to program or erase these two blocks may fail.

Workaround: There are two workarounds for this erratum:

- 1) Set WP#=V_{IH} when programming or erasing blocks #63 and #64. In addition, hold V_{PP}≤V_{PPLK} when not programming or erasing for additional protection against accidental writes; and
- 2) Temporarily, have software swap the contents of blocks #63 and #64 with the contents of blocks #69 and #70. If code was originally in blocks #69 and #70, utilize jump routine to blocks #63 and #64.

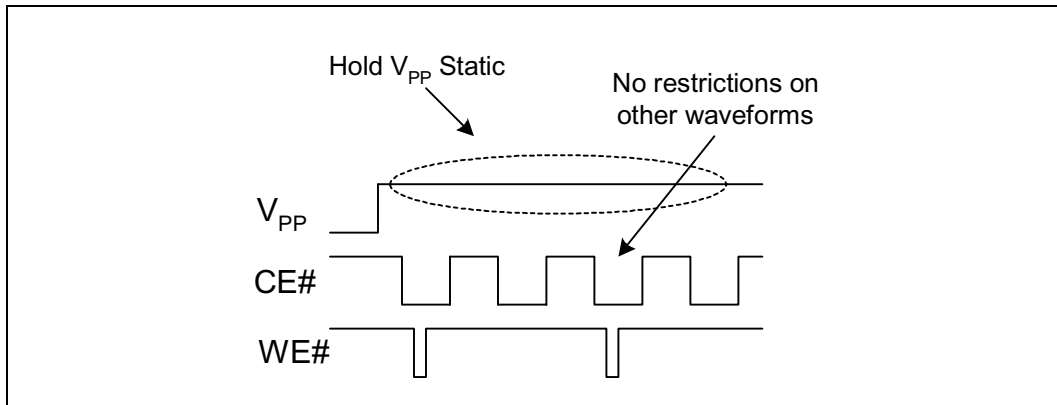
Problem: The 0.18μm 28F320B3xC devices can unintentionally reset under certain conditions where V_{PP} toggles.

Implication: When the reset occurs, any command being executed is interrupted and the flash switches to read array mode.

- 1) Tie V_{PP} to V_{CC}
- 2) If the third and fourth digits on the top side FPO mark (third line) are equal or greater than “23”, then V_{CC} may be set from 2.7 V to 3.3 V. V_{CC} must not exceed 3.3 V.
- 3) Set V_{PP} to a static high or static low level as shown here; and

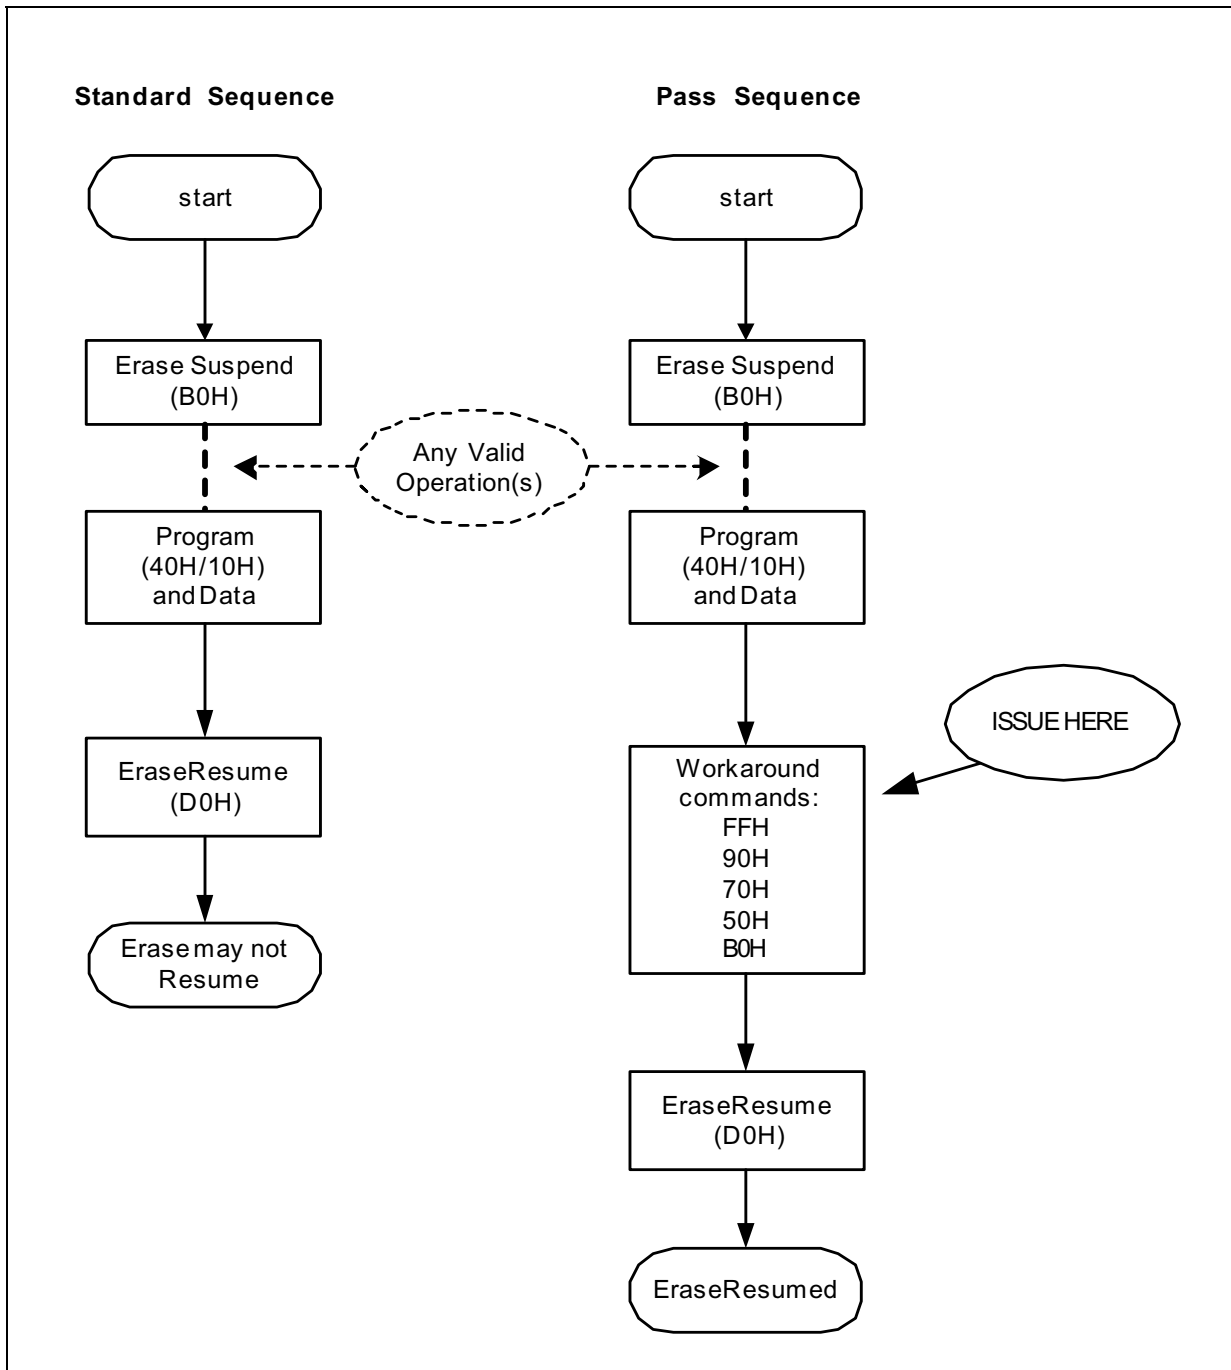
Figure 1. Workaround Placement

Problem: On the 0.18µm 28F160B3xC device, a design anomaly was discovered. During an Erase-Suspend operation, if the Program (40H/10H) sequence is executed, under limited conditions the proceeding Erase Resume command (D0H) may not actually resume the device. No customers have reported failures in product applications. Customers who use any version of FDI (Intel Flash Data Integrator) software will not see this issue. If the Read Array command is issued prior to the Erase Resume command, users will not see the issue (typical in XIP applications).

Implication: The Resume Command (D0H) may be ignored by the device and will not correctly resume. The device will appear to remain in suspend (via status register). After a reset of the flash device the status register will clear. This failure has been recreated in a lab environment only.

1. If FDI (Intel Flash Data Integrator) software is used, users will not see the issue.
2. During an Erase-Suspend (B0H), user must issue any of the following commands listed in Table-1 after issuing the Program (40H/10H) and data sequence but before issuing the Erase-Resume (D0H) command.
