# MC33661, Masks M98Z and L06R, Errata

This errata document applies to the MC33661 LIN transceiver IC, powered by SMARTMOS technology.

Document Number: MC33661ER  
Rev. 3.0  
01/2014

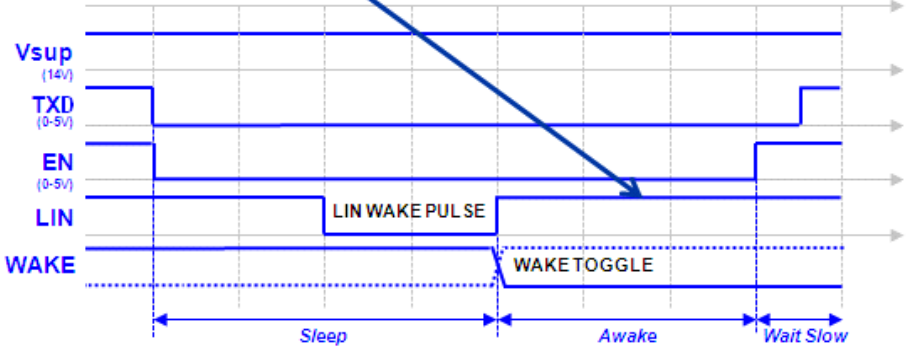
<p data-bbox="678 808 1042 840"><b>Figure 1. Expected Behavior</b></p>
ER02			<p data-bbox="430 882 852 945">Due to anomalous behavior, LIN is driven by TXD state when EN is 'low'</p>

Errata No.	Erratum	System Impact	Description
ER02			<p data-bbox="446 346 836 409">State of TXD is ignored by the LIN BUS because EN is 'low'</p>

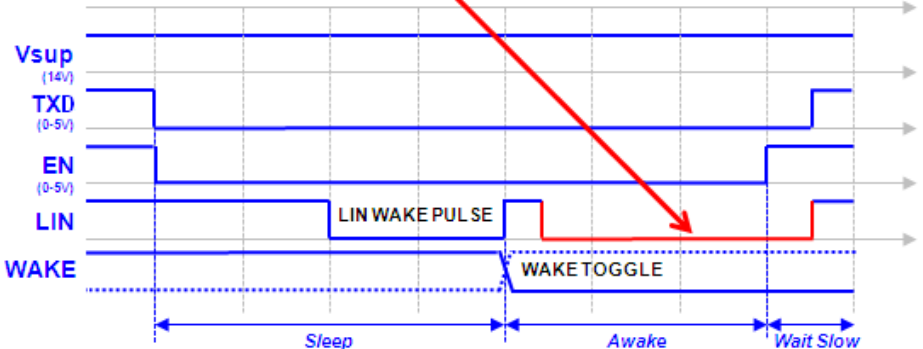
<p data-bbox="662 1344 1058 1375"><b>Figure 2. Unexpected Behavior</b></p>

Errata No.	Erratum	System Impact	Description
<b>Low Severity</b>			
ER02	LIN BUS driven by TXD when EN is 'low'	<p>When the anomalous behavior is present, the LIN bus will be driven by the state of TXD even if EN is 'low'. When transitioning from Awake into Wait Slow state, the TXD must be 'low', so in this case, the LIN will be driven 'dominant'. In this state, communication on the LIN bus is not possible during the duration of TXD 'low'.</p> <p><a href="#">Figure 1.</a> and <a href="#">Figure 2.</a></p>	<p>During the transition into Sleep state (pulling EN pin 'low') and then transitioning into the Awake state by receiving a LIN wake-up pulse or a WAKE pin toggle, the TXD could drive the state of the LIN, even if the EN pin is 'low'. If this occurs and the TXD pin is low, the LIN pin will be driven dominant until the TXD pin goes high. Empirical measurements show that the probability of this anomalous behavior is in the range of 1 out of every 4000 transitions into Sleep state (EN pin pulled 'low').</p> <p><b>Root Cause:</b> The anomalous behavior is caused by an asynchronous event when EN is pulled 'low' at about the same time (within a few nanoseconds) as an internal oscillator signal goes 'high'. This creates a race condition of the state machine, and one of the two signals required for the LIN transmitter to be activated does not transition properly, remaining in the enable state. Once the transceiver receives a LIN wake-up pulse or the WAKE pin is toggled, the other necessary signal to activate the LIN transmitter is triggered and the state of TXD drives the LIN bus, even though it should be disabled.</p> <p><b>It should also be noted that when the issue occurs, the sleep current (<math>I_{SLEEP}</math>) increases from 8.0 typ. to 71 <math>\mu A</math> at 13.5 V. When the state machine transitions properly, this extra current draw is not present.</b></p> <p><b>Workaround:</b></p> <ol style="list-style-type: none"> <li>1. Ensure the TXD pin is in the "high" state during Sleep and Awake modes. In this case, even if the driver is enabled, a dominant pulse is not present on the bus when the anomalous behavior occurs. The consequence to this method is that it is not possible to transition the device to the Wait Slow mode, and ultimately Slow mode operation, because TXD needs to be low during Awake mode to transition to the Wait Slow state.</li> <li>2. When the anomalous behavior is present, the node issuing a wake-up signal on the LIN bus must retry by sending a new wake up signal (in accordance with section 2.6.2 WAKE-UP of the LIN 2.2 specification). This method allows the continued use of Slow mode.</li> </ol> <p><b>Fix Plan/Status:</b> None</p>
