PIC16(L)F1933 Silicon Errata and Data Sheet Clarification

The PIC16(L)F1933 family devices that you have received conform functionally to the current Device Data Sheet (DS41575C), except for the anomalies described in this document.

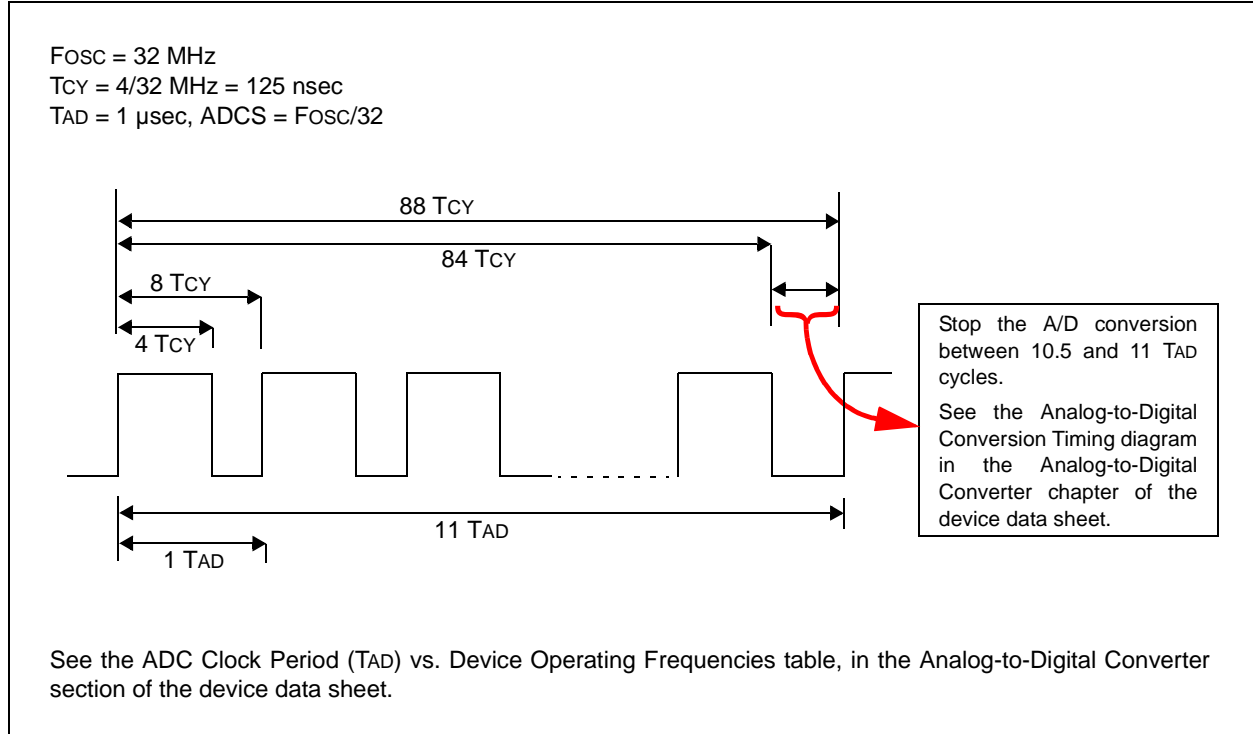
FIGURE 1: INSTRUCTION CYCLE DELAY CALCULATION EXAMPLE

An ADC conversion may not complete under these conditions:

1. When FOSC is greater than 8 MHz and it is the clock source used for the ADC converter.
2. The ADC is operating from its dedicated internal FRC oscillator and the device is not in Sleep mode (any FOSC frequency).

When this occurs, the ADC Interrupt Flag (ADIF) does not get set, the GO/DONE bit does not get cleared, and the conversion result does not get loaded into the ADRESH and ADRESL result registers.

In [Figure 1](#), 88 instruction cycles (Tcy) will be required to complete the full conversion. Each TAD cycle consists of 8 Tcy periods. A fixed delay is provided to stop the A/D conversion after 86 instruction cycles and terminate the conversion at the correct time as shown in the figure above.

Note: The exact delay time will depend on the TAD divisor (ADCS) selection. The Tcy counts shown in the timing diagram above apply to this example only. Refer to [Table 4](#) for the required delay counts for other configurations.

Method 3: This method is provided if the application cannot use Sleep mode and requires continuous operation at frequencies above 8 MHz. This method requires early termination of an ADC conversion. Provide a fixed time delay in software to stop the A-to-D conversion manually, after all 10 bits are converted, but before the conversion would complete automatically. The conversion is stopped by clearing the GO/DONE bit in software. The GO/DONE bit must be cleared during the last ½ TAD cycle, before the conversion would have completed automatically. Refer to [Figure 1](#) for details.

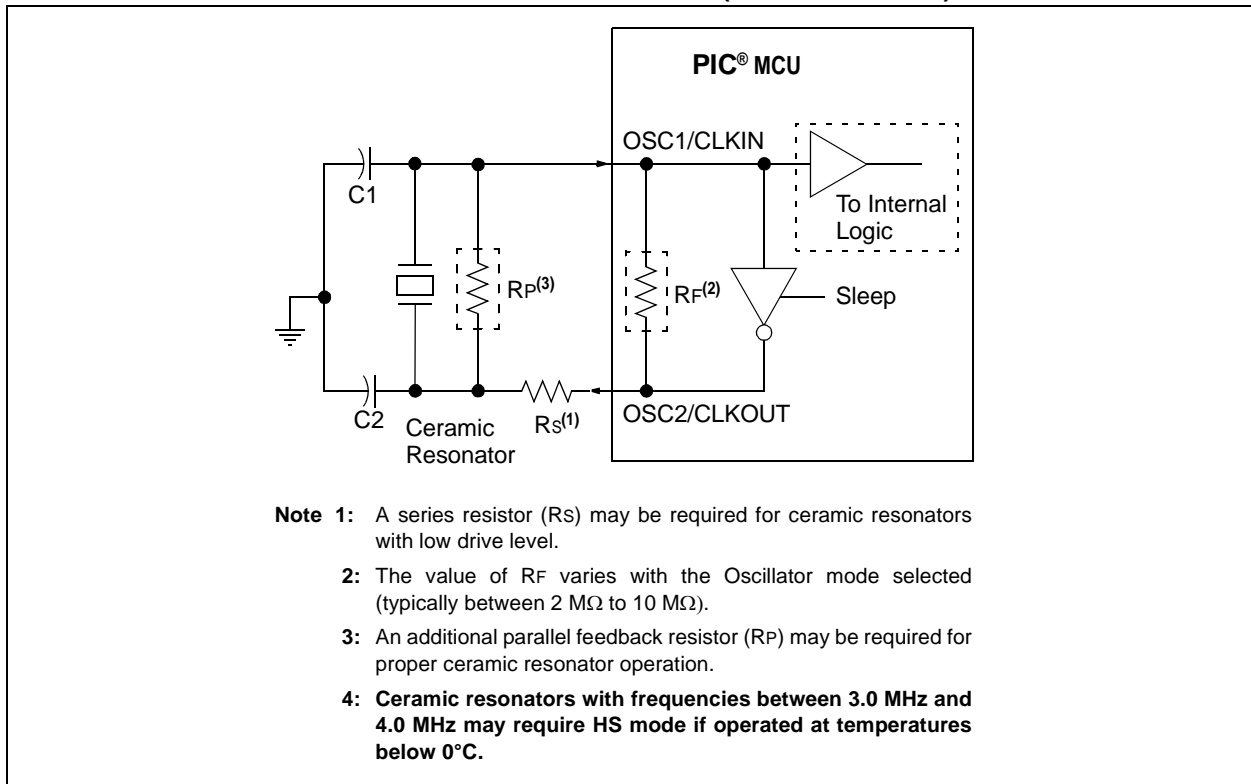
FIGURE 5-4: CERAMIC RESONATOR OPERATION (XT OR HS MODE)

In [Figure 5-4](#), note 4 is added as following:
