PIC16(L)F1938/1939 Silicon Errata and Data Sheet Clarification

The PIC16(L)F1938/1939 family devices that you have received conform functionally to the current Device Data Sheet (DS40001574C), except for the anomalies described in this document.

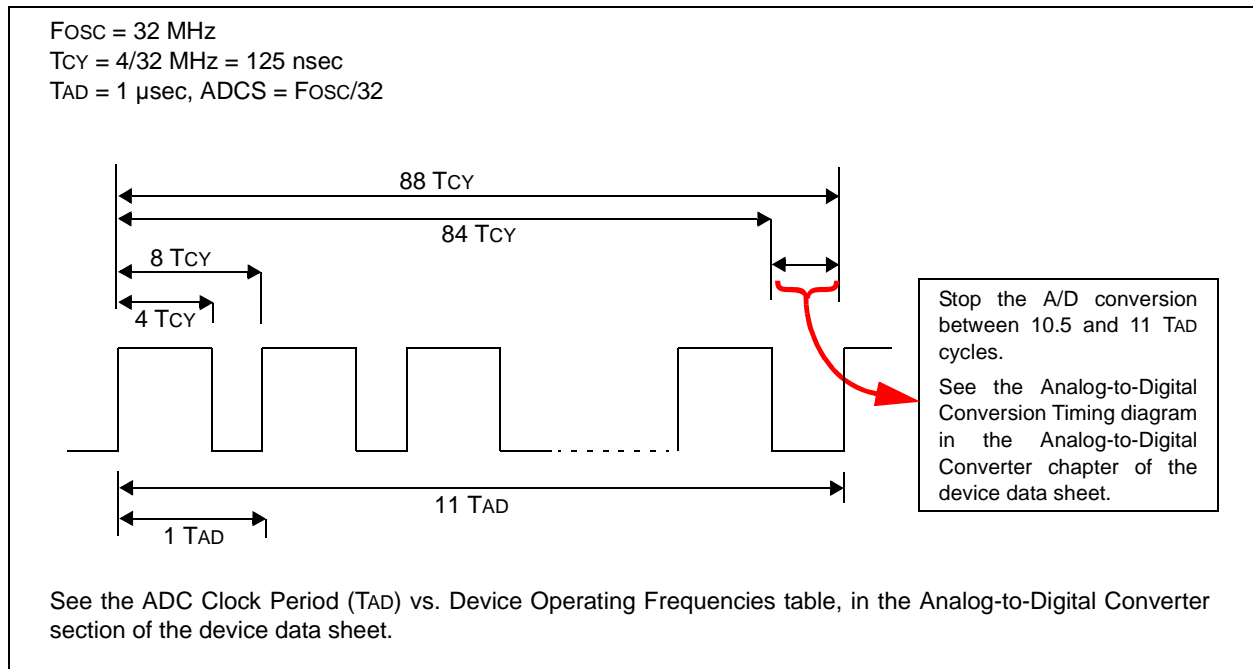
FIGURE 1: INSTRUCTION CYCLE DELAY CALCULATION EXAMPLE

An ADC conversion may not complete under these conditions:

1. When FOSC is greater than 8 MHz and it is the clock source used for the ADC converter.
2. The ADC is operating from its dedicated internal FRC oscillator and the device is not in Sleep mode (any FOSC frequency).

When this occurs, the ADC Interrupt Flag (ADIF) does not get set, the GO/DONE bit does not get cleared, and the conversion result does not get loaded into the ADRESH and ADRESL result registers.

In Figure 1, 88 instruction cycles (Tcy) will be required to complete the full conversion. Each TAD cycle consists of 8 Tcy periods. A fixed delay is provided to stop the A/D conversion after 86 instruction cycles and terminate the conversion at the correct time as shown in the figure above.

Method 3: This method is provided if the application cannot use Sleep mode and requires continuous operation at frequencies above 8 MHz. This method requires early termination of an ADC conversion. Provide a fixed time delay in software to stop the A-to-D conversion manually, after all 10 bits are converted, but before the conversion would complete automatically. The conversion is stopped by clearing the GO/DONE bit in software. The GO/DONE bit must be cleared during the last 1/2 TAD cycle, before the conversion would have completed automatically. Refer to Figure 1 for details.

Note: The exact delay time will depend on the TAD divisor (ADCS) selection. The Tcy counts shown in the timing diagram above apply to this example only. Refer to Table 3 for the required delay counts for other configurations.
