## PIC18F6627/6722/8627/8722 Rev. A1 Silicon Errata

The PIC18F6627/6722/8627/8722 parts you have received conform functionally to the Device Data Sheet (DS39646B), except for the anomalies described below. Any Data Sheet Clarification issues related to the PIC18F6627/6722/8627/8722 devices will be reported in a separate Data Sheet errata. Please check the Microchip web site for any existing issues.

**The following silicon errata apply only to PIC18F6627/6722/8627/8722 devices with these Device/Revision IDs:**

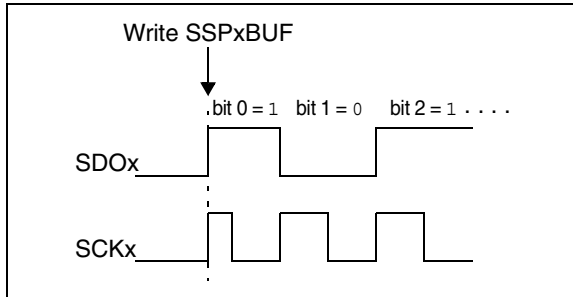
**FIGURE 1: SCKx PULSE VARIATION USING TIMER2/2**

When the SPI is using Timer2/2 as the clock source, a shorter than expected SCKx pulse may occur on the first bit of the transmitted/received data (Figure 1).

To avoid producing the short pulse, turn off Timer2 and clear the TMR2 register, load the SSPxBUF with the data to transmit and then turn Timer2 back on. Refer to Example 4 for sample code.
