PIC24FJ256GB110 Family Silicon Errata and Data Sheet Clarification

The PIC24FJ256GB110 family devices that you have received conform functionally to the current Device Data Sheet (DS39897C), except for the anomalies described in this document.

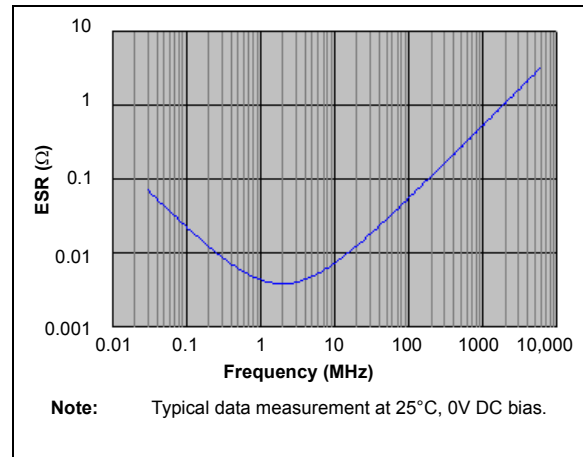
FIGURE 2-3 FREQUENCY vs. ESR PERFORMANCE FOR SUGGESTED VCAP

The placement of this capacitor should be close to VCAP/VDDCORE. It is recommended that the trace length not exceed 0.25 inch (6 mm). Refer to **Section 29.0 “Electrical Characteristics”** for additional information.

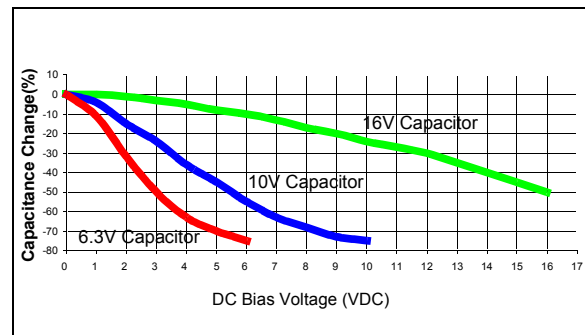
FIGURE 2-4 DC BIAS VOLTAGE vs. CAPACITANCE CHARACTERISTICS

A typical DC bias voltage vs. capacitance graph for 16V, 10V and 6.3V rated capacitors is shown in Figure 2-4.

When selecting a ceramic capacitor to be used with the internal voltage regulator, it is suggested to select a high-voltage rating, so that the operating voltage is a small percentage of the maximum rated capacitor voltage. For example, choose a ceramic capacitor rated at 16V for the 2.5V core voltage. Suggested capacitors are shown in Table 2-1.

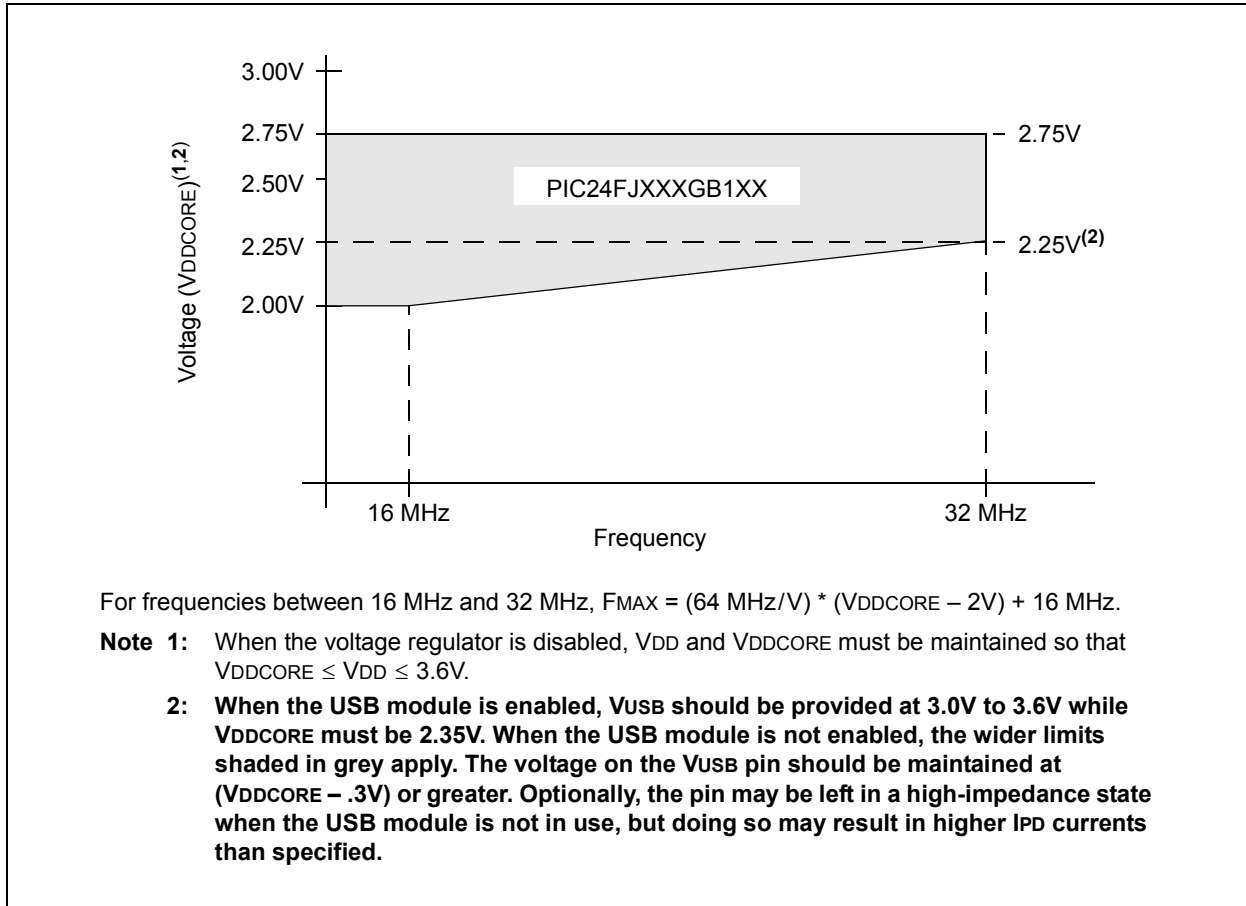
FIGURE 29-1: PIC24FJ256GB110 FAMILY VOLTAGE-FREQUENCY GRAPH (INDUSTRIAL)

Figure 29-1 (“PIC24FJ256GB110 Family Voltage-Frequency Graph”) is amended by adding an additional footnote. The updated figure is shown below (changes in **bold**; bold in original removed for clarity).
