3 Volt Intel[®] Advanced+ Boot Block Flash Memory

28F800C3, 28F160C3, 28F320C3, 28F640C3

Specification Update

Order Number: 297938-014

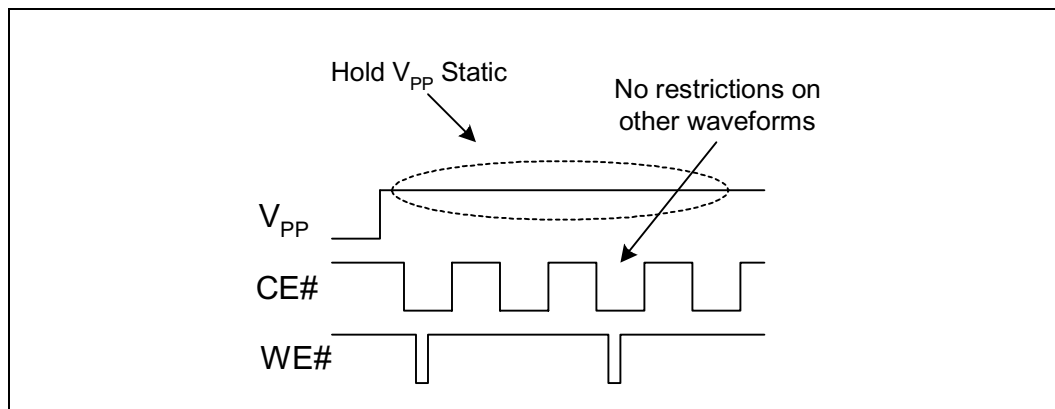
Problem: The 0.18 μ m 28F320C3xC devices can unintentionally reset under certain conditions where V_{pp} toggles.

Implication: When the reset occurs, any command being executed is interrupted and the flash switches to read array mode.

- 1) Tie V_{pp} to V_{CC} ;
- 2) If the third and fourth digits on the top side FPO mark (third line) is equal or greater than “23”, then V_{CC} may be set from 2.7v to 3.3v. V_{CC} must not exceed 3.3v
- 3) Set V_{pp} to a static high or static low level as shown here; and
