# THE DATASHEET OF RC28F320J3A110

# ***3 Volt Intel StrataFlash<sup>®</sup> Memory***

## ***28F128J3A, 28F640J3A, 28F320J3A***

### **Specification Update**

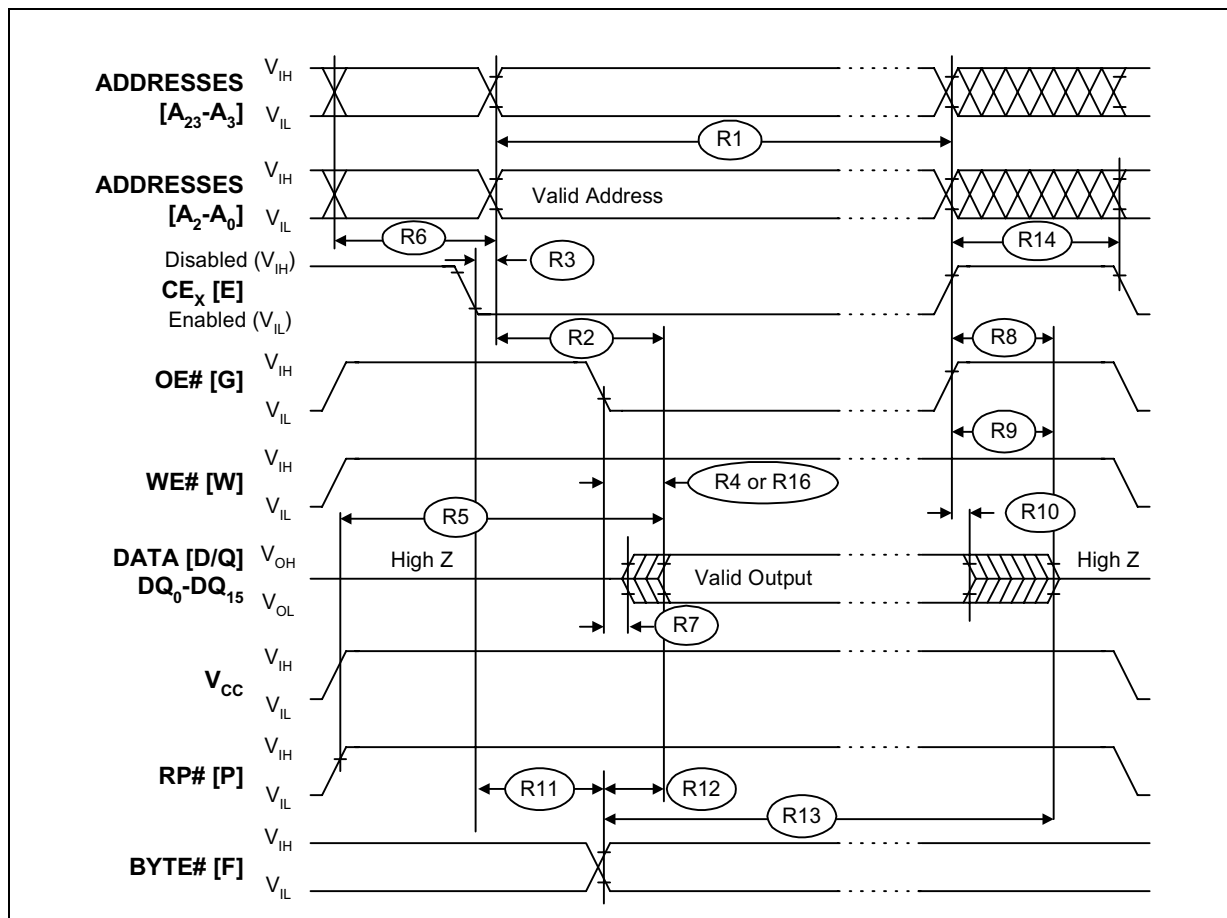
Figure 1. AC Waveform for Standard Word/Byte Read Operations

Problem: Devices need the parameter  $t_{ELQX}$  = 150 ns minimum. CE low to output in low Z ( $t_{ELQX}$ ) is designated as R6 in Figure 1, in this Specification Update revision.

Problem: Devices need the parameter  $t_{ELAV}$  = 500 ns maximum. Chip Enable to Address Valid ( $t_{ELAV}$ ) is designated as R3 in Figure 1, in this Specification Update revision.

Workaround: Use devices for initial lower volume prototype development.
