3 Volt Intel[®] Advanced+ Boot Block Flash Memory

28F800C3, 28F160C3, 28F320C3, 28F640C3

Specification Update

Order Number: 297938-014

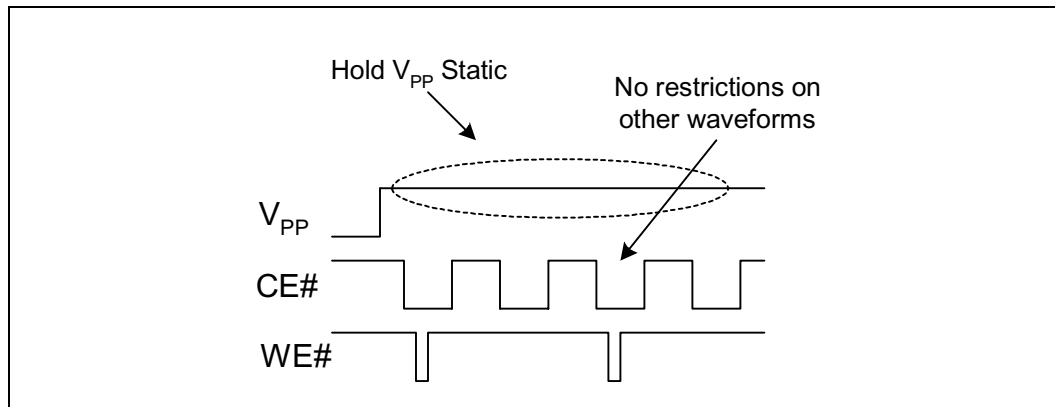
2. 28F320C3xC Reset Failure

Problem: The 0.18 μ m 28F320C3xC devices can unintentionally reset under certain conditions where V_{pp} toggles.

Implication: When the reset occurs, any command being executed is interrupted and the flash switches to read array mode.

- 1) Tie V_{pp} to V_{CC} ;
- 2) If the third and fourth digits on the top side FPO mark (third line) is equal or greater than “23”, then V_{CC} may be set from 2.7v to 3.3v. V_{CC} must not exceed 3.3v
- 3) Set V_{pp} to a static high or static low level as shown here; and

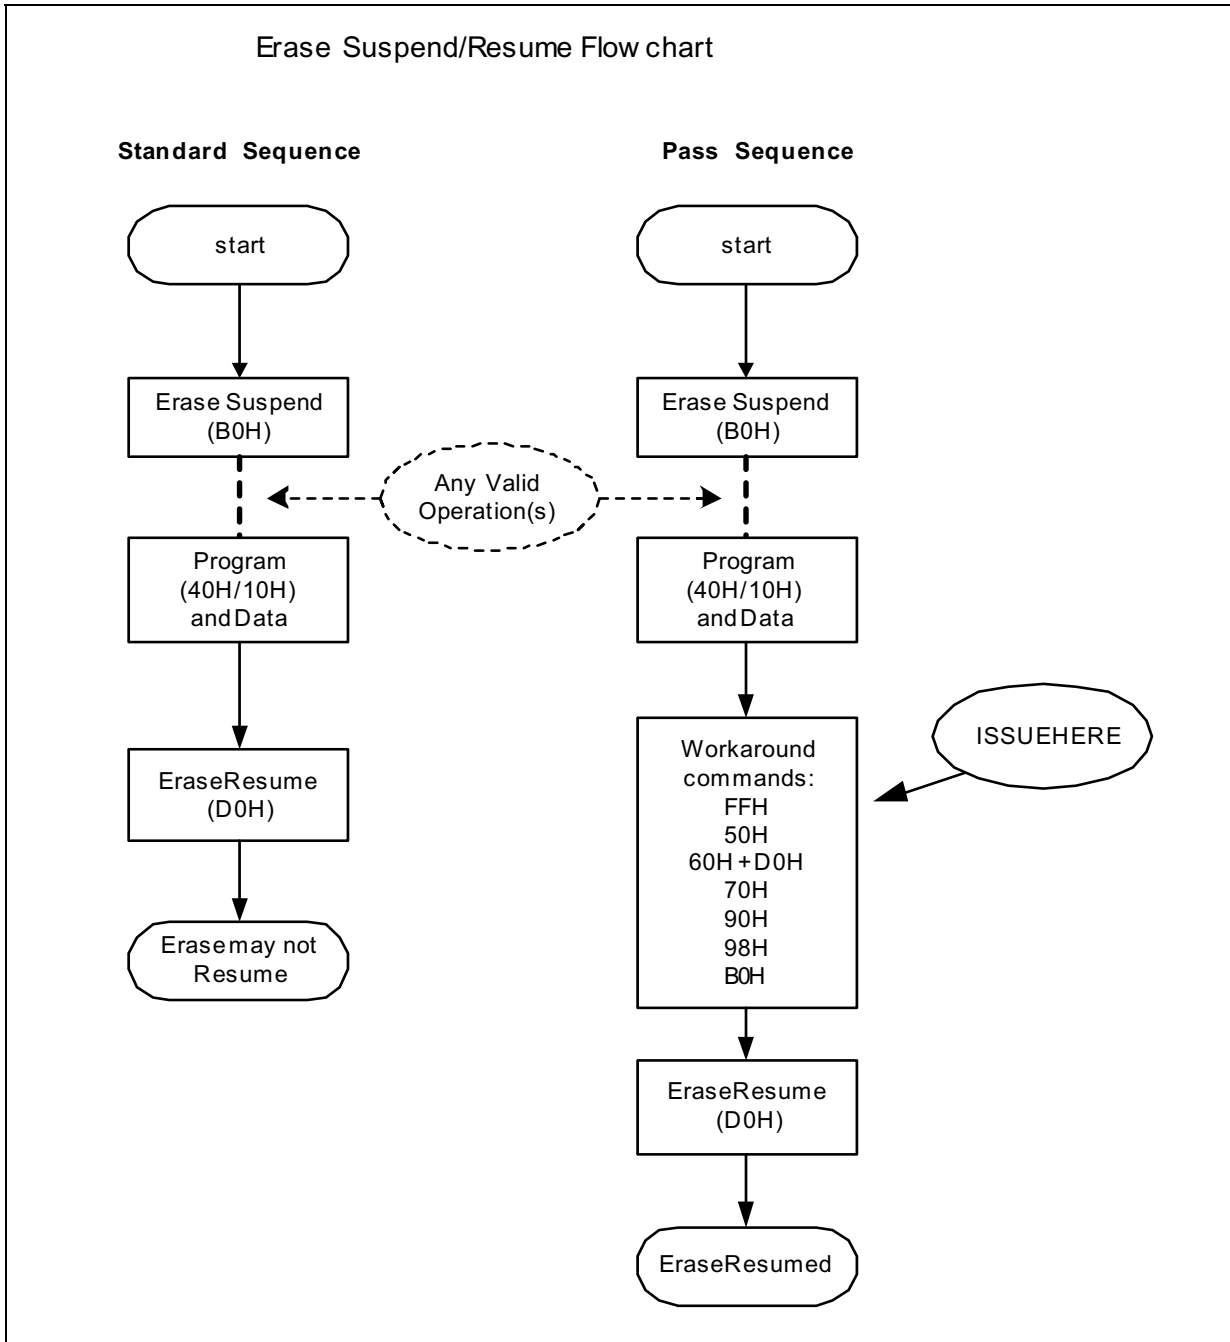
Figure 1. Workaround Placement

Problem: On the 0.18µm 28F160C3xC devices, a design anomaly was discovered. During an Erase-Suspend operation, if the Program (40H/10H) sequence is executed, under limited conditions the proceeding Erase Resume command (D0H) may not actually resume the device. No customers have reported failures in product applications. Customers who use any version of FDI (Intel Flash Data Integrator) software will not see this issue. If the Read Array command is issued prior to the Erase Resume command, users will not see the issue (typical in XIP applications).

Implication: The Resume Command (D0H) may be ignored by the device and will not correctly resume. The device will appear to remain in suspend (via status register). After a reset of the flash device the status register will clear. This failure has been recreated in a lab environment only.

1. If FDI (Intel Flash Data Integrator) software is used, users will not see the issue.
2. During an Erase-Suspend (B0H), user must issue any of the following commands after issuing the Program (40H/10H) and data sequence but before issuing the Erase-Resume (D0H) command.

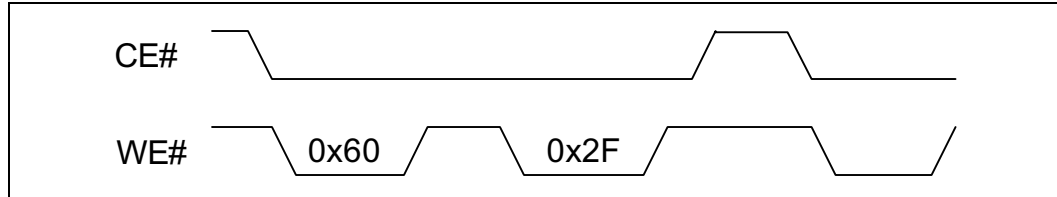
Problem: On the 16Mb and 64Mb 0.18µm devices, if CE# is deasserted after any block lock operation and before the next write sequence, the part may perform the same operation on additional blocks. (See waveform below.)

Implication: When CE# is deasserted after performing a block lock operation to a specific block and prior to the next write sequence, other blocks may perform the same operation.
