PIC16(L)F1934/1936/1937 Family Silicon Errata and Data Sheet Clarification

The PIC16(L)F1934/1936/1937 family devices that you have received conform functionally to the current Device Data Sheet (DS41364E), except for the anomalies described in this document.

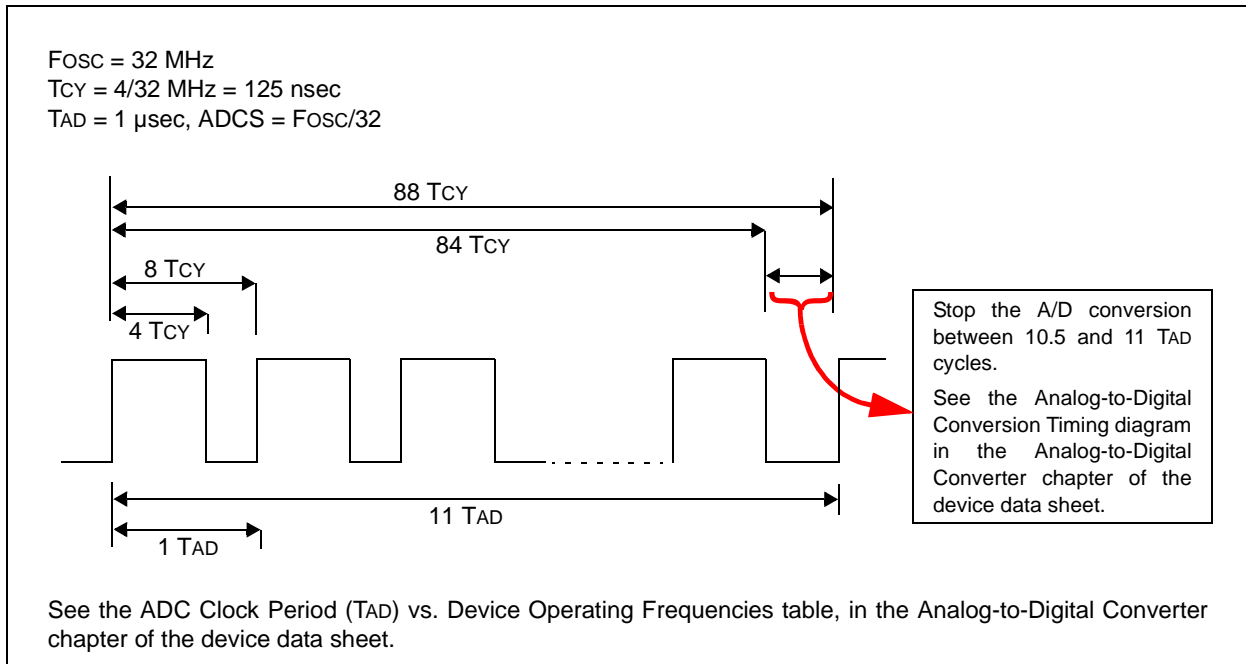
FIGURE 1: INSTRUCTION CYCLE DELAY CALCULATION EXAMPLE

5.1 Analog-to-Digital Conversion

An ADC conversion may not complete under these conditions:

1. When FOSC is greater than 8 MHz and it is the clock source used for the ADC converter.
2. The ADC is operating from its dedicated internal FRC oscillator and the device is not in Sleep mode (any FOSC frequency).

When this occurs, the ADC Interrupt Flag (ADIF) does not get set, the GO/DONE bit does not get cleared, and the conversion result does not get loaded into the ADRESH and ADRESL result registers.

In [Figure 1](#), 88 instruction cycles (TCY) will be required to complete the full conversion. Each TAD cycle consists of 8 TCY periods. A fixed delay is

provided to stop the A/D conversion after 86 instruction cycles and terminate the conversion at the correct time as shown in the figure above.

Method 3: This method is provided if the application cannot use Sleep mode and requires continuous operation at frequencies above 8 MHz. This method requires early termination of an ADC conversion. Provide a fixed time delay in software to stop the A-to-D conversion manually, after all 10 bits are converted, but before the conversion would complete automatically. The conversion is stopped by clearing the GO/DONE bit in software. The GO/DONE bit must be cleared during the last 1/2 TAD cycle, before the conversion would have completed automatically. Refer to [Figure 1](#) for details.

Note: The exact delay time will depend on the TAD divisor (ADCS) selection. The Tcy counts shown in the timing diagram above apply to this example only. Refer to [Table 3](#) for the required delay counts for other configurations.
