MC33661, Masks M98Z and L06R, Errata

This errata document applies to the MC33661 LIN transceiver IC, powered by SMARTMOS technology.

Document Number: MC33661ER
Rev. 3.0
01/2014

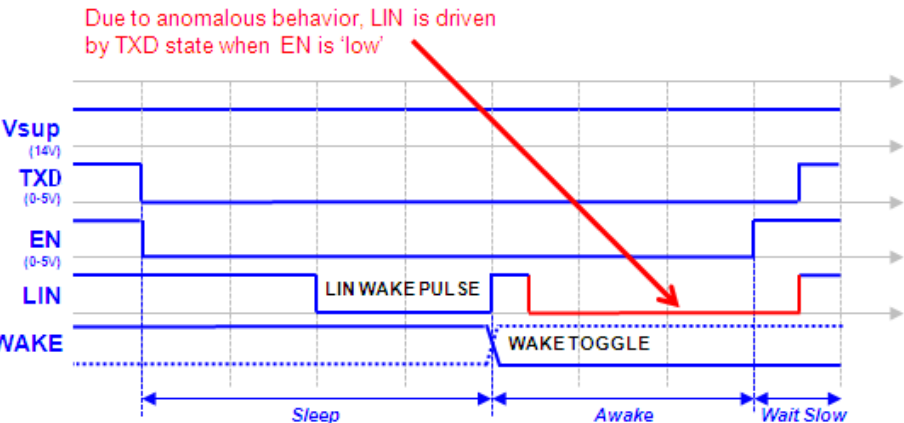
<p>Figure 2. Unexpected Behavior</p>

Errata No.	Erratum	System Impact	Description
Low Severity			
ER02	LIN BUS driven by TXD when EN is 'low'	<p>When the anomalous behavior is present, the LIN bus will be driven by the state of TXD even if EN is 'low'. When transitioning from Awake into Wait Slow state, the TXD must be 'low', so in this case, the LIN will be driven 'dominant'. In this state, communication on the LIN bus is not possible during the duration of TXD 'low'.</p> <p>Figure 1. and Figure 2.</p>	<p>During the transition into Sleep state (pulling EN pin 'low') and then transitioning into the Awake state by receiving a LIN wake-up pulse or a WAKE pin toggle, the TXD could drive the state of the LIN, even if the EN pin is 'low'. If this occurs and the TXD pin is low, the LIN pin will be driven dominant until the TXD pin goes high. Empirical measurements show that the probability of this anomalous behavior is in the range of 1 out of every 4000 transitions into Sleep state (EN pin pulled 'low').</p> <p>Root Cause: The anomalous behavior is caused by an asynchronous event when EN is pulled 'low' at about the same time (within a few nanoseconds) as an internal oscillator signal goes 'high'. This creates a race condition of the state machine, and one of the two signals required for the LIN transmitter to be activated does not transition properly, remaining in the enable state. Once the transceiver receives a LIN wake-up pulse or the WAKE pin is toggled, the other necessary signal to activate the LIN transmitter is triggered and the state of TXD drives the LIN bus, even though it should be disabled.</p> <p>It should also be noted that when the issue occurs, the sleep current (I_{SLEEP}) increases from 8.0 typ. to 71 μA at 13.5 V. When the state machine transitions properly, this extra current draw is not present.</p> <p>Workaround:</p> <ol style="list-style-type: none"> 1. Ensure the TXD pin is in the "high" state during Sleep and Awake modes. In this case, even if the driver is enabled, a dominant pulse is not present on the bus when the anomalous behavior occurs. The consequence to this method is that it is not possible to transition the device to the Wait Slow mode, and ultimately Slow mode operation, because TXD needs to be low during Awake mode to transition to the Wait Slow state. 2. When the anomalous behavior is present, the node issuing a wake-up signal on the LIN bus must retry by sending a new wake up signal (in accordance with section 2.6.2 WAKE-UP of the LIN 2.2 specification). This method allows the continued use of Slow mode. <p>Fix Plan/Status: None</p>

<p>Figure 1. Expected Behavior</p>
ER02			<p>Due to anomalous behavior, LIN is driven by TXD state when EN is 'low'</p>
