MC33661, Masks M98Z and L06R, Errata

This errata document applies to the MC33661 LIN transceiver IC, powered by SMARTMOS technology.

Document Number: MC33661ER
Rev. 3.0
01/2014

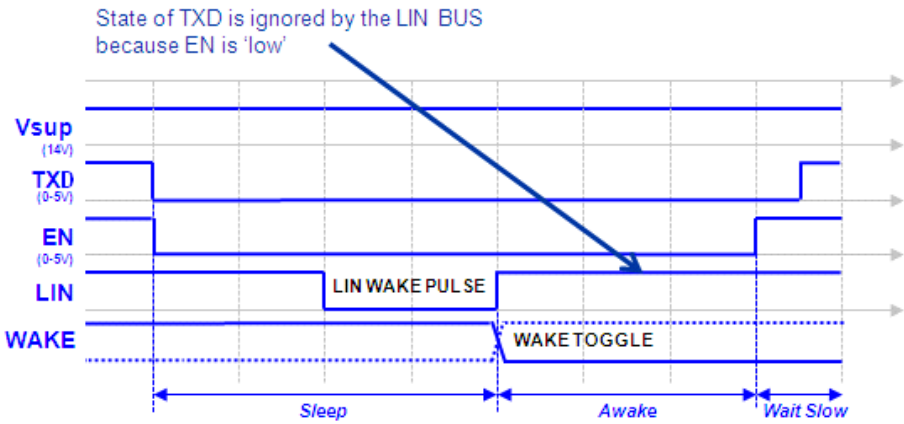
Errata No.	Erratum	System Impact	Description
ER02			<p>State of TXD is ignored by the LIN BUS because EN is 'low'</p>

<p>Figure 1. Expected Behavior</p>
ER02			<p>Due to anomalous behavior, LIN is driven by TXD state when EN is 'low'</p>

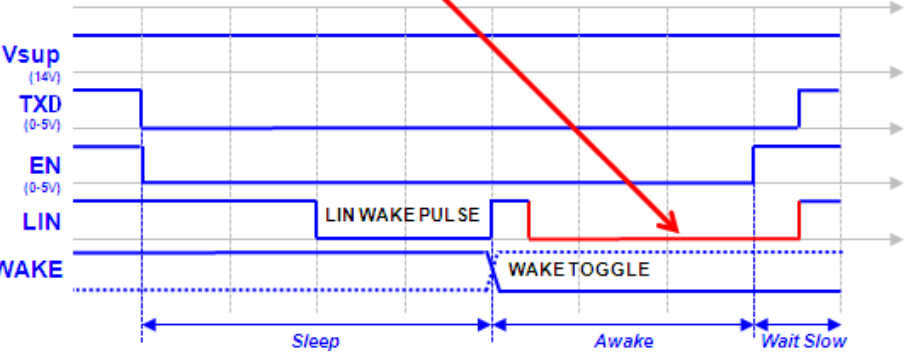
<p>Figure 2. Unexpected Behavior</p>

Errata No.	Erratum	System Impact	Description
Low Severity			
ER02	LIN BUS driven by TXD when EN is 'low'	<p>When the anomalous behavior is present, the LIN bus will be driven by the state of TXD even if EN is 'low'. When transitioning from Awake into Wait Slow state, the TXD must be 'low', so in this case, the LIN will be driven 'dominant'. In this state, communication on the LIN bus is not possible during the duration of TXD 'low'.</p> <p>Figure 1. and Figure 2.</p>	<p>During the transition into Sleep state (pulling EN pin 'low') and then transitioning into the Awake state by receiving a LIN wake-up pulse or a WAKE pin toggle, the TXD could drive the state of the LIN, even if the EN pin is 'low'. If this occurs and the TXD pin is low, the LIN pin will be driven dominant until the TXD pin goes high. Empirical measurements show that the probability of this anomalous behavior is in the range of 1 out of every 4000 transitions into Sleep state (EN pin pulled 'low').</p> <p>Root Cause: The anomalous behavior is caused by an asynchronous event when EN is pulled 'low' at about the same time (within a few nanoseconds) as an internal oscillator signal goes 'high'. This creates a race condition of the state machine, and one of the two signals required for the LIN transmitter to be activated does not transition properly, remaining in the enable state. Once the transceiver receives a LIN wake-up pulse or the WAKE pin is toggled, the other necessary signal to activate the LIN transmitter is triggered and the state of TXD drives the LIN bus, even though it should be disabled.</p> <p>It should also be noted that when the issue occurs, the sleep current (I_{SLEEP}) increases from 8.0 typ. to 71 μA at 13.5 V. When the state machine transitions properly, this extra current draw is not present.</p> <p>Workaround:</p> <ol style="list-style-type: none"> 1. Ensure the TXD pin is in the "high" state during Sleep and Awake modes. In this case, even if the driver is enabled, a dominant pulse is not present on the bus when the anomalous behavior occurs. The consequence to this method is that it is not possible to transition the device to the Wait Slow mode, and ultimately Slow mode operation, because TXD needs to be low during Awake mode to transition to the Wait Slow state. 2. When the anomalous behavior is present, the node issuing a wake-up signal on the LIN bus must retry by sending a new wake up signal (in accordance with section 2.6.2 WAKE-UP of the LIN 2.2 specification). This method allows the continued use of Slow mode. <p>Fix Plan/Status: None</p>
