## PIC16F88X Family Silicon Errata and Data Sheet Clarification

The PIC16F88X family devices that you have received conform functionally to the current Device Data Sheet (DS41291G), except for the anomalies described in this document.

The silicon issues discussed in the following pages are for silicon revisions with the Device and Revision IDs listed in [Table 1](#). The silicon issues are summarized in [Table 2](#), [Table 3](#) and [Table 4](#).

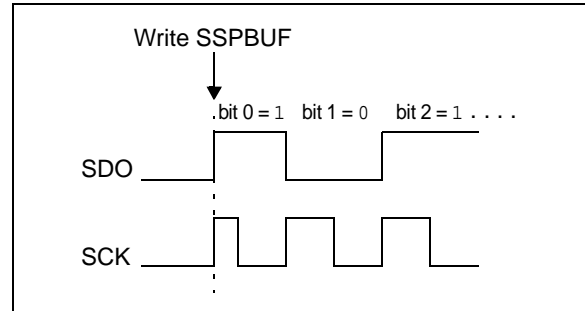
**FIGURE 1: SCK PULSE VARIATION USING TIMER2/2**

When the SPI is using Timer2/2 as the clock source, a shorter than expected SCK pulse may occur on the first bit of the transmitted/received data (Figure 1).

To avoid producing the short pulse, turn off Timer2 and clear the TMR2 register, load SSPBUF with the data to transmit and then turn Timer2 back on. Refer to Example 1 for sample code.

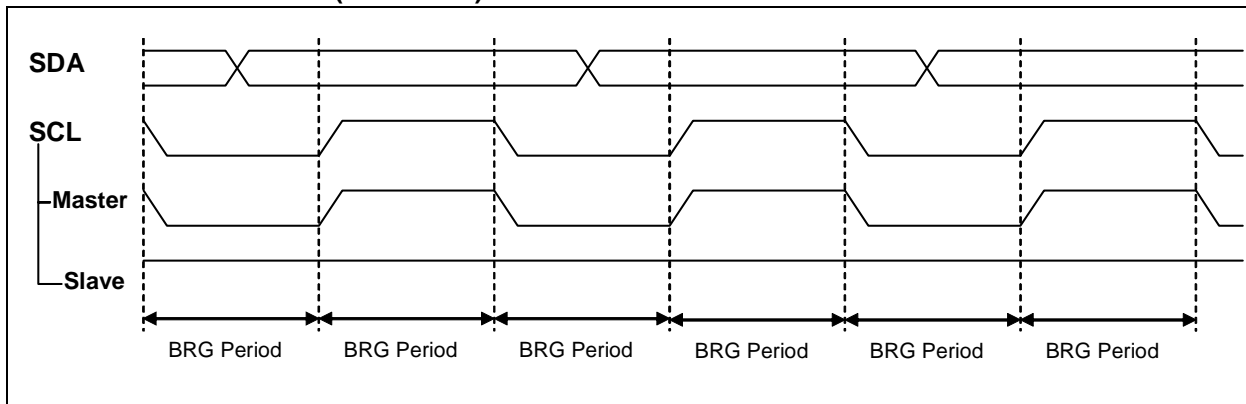
**FIGURE 1: ACTUAL (CORRECT) OPERATION WITHOUT CLOCK STRETCHING**

Figure 1 illustrates an expected I<sup>2</sup>C transmission in which the SCL line is completely controlled by the master device and the slave device does not attempt to stretch the clock period.

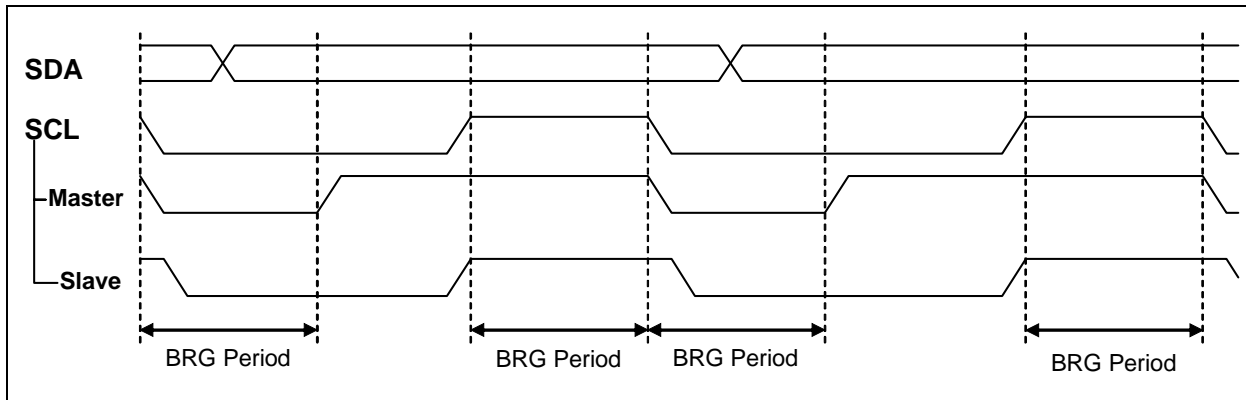
**FIGURE 2: EXPECTED OPERATION WITH CLOCK STRETCHING**

Figure 2 illustrates the expected operation of an I<sup>2</sup>C transmission in which the slave device has stretched the clock period by holding the SCL line low. The high time of the SCL pulse is constant, regardless of the duration of the clock stretch.

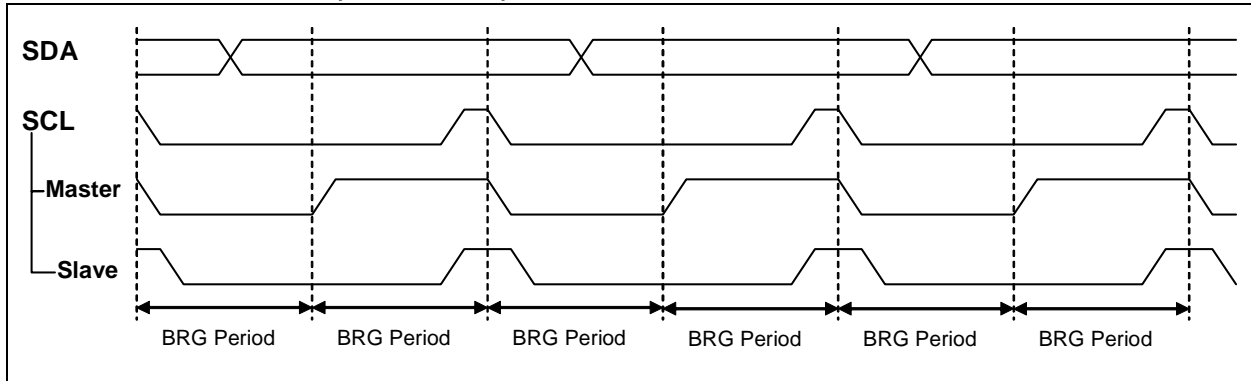
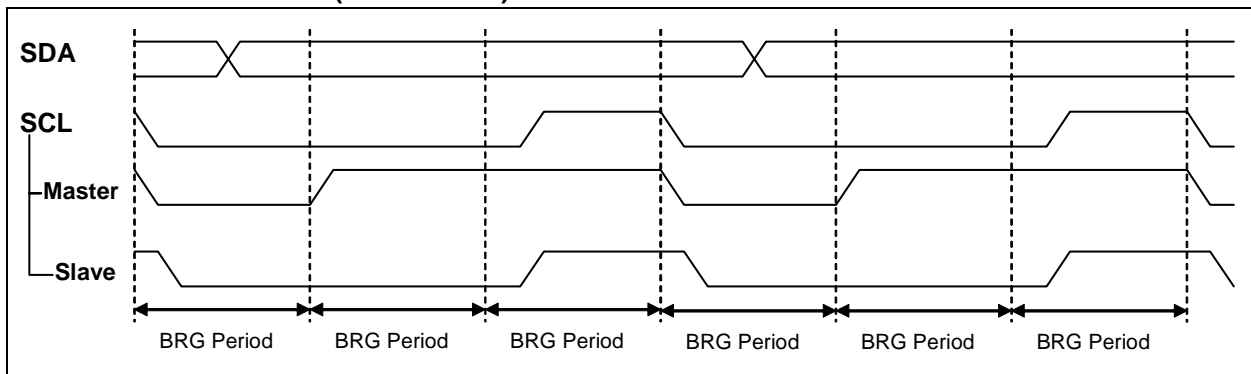
The current implementation does not ensure accurate SCL high time. During clock stretch, the MSSP device will erroneously continue running the BRG counter. At the end of the clock stretch, the BRG counter continues to count down for the

remainder of the BRG period, and then the MSSP device will immediately resume transmitting the data.

Figure 3 and Figure 4 illustrate an actual I<sup>2</sup>C transmission in which the slave has stretched the clock period by holding the SCL line low. Note that the high time of the SCL signal has shortened from the expected time.

**FIGURE 3: ACTUAL (INCORRECT) OPERATION WITH CLOCK STRETCHING – EXAMPLE 1**

**FIGURE 4: ACTUAL (INCORRECT) OPERATION WITH CLOCK STRETCHING – EXAMPLE 2**

Set the communication speed to match the slowest device on the bus. This ensures that no slave device will perform clock stretching.

It is possible to dynamically adjust the communication speed to match the device being addressed by modifying the BRG register. However, the behavior of slower slave devices must be understood and speed adjustments made such that no slave performs clock stretching.
