PIC16F88X Family Silicon Errata and Data Sheet Clarification

The PIC16F88X family devices that you have received conform functionally to the current Device Data Sheet (DS41291G), except for the anomalies described in this document.

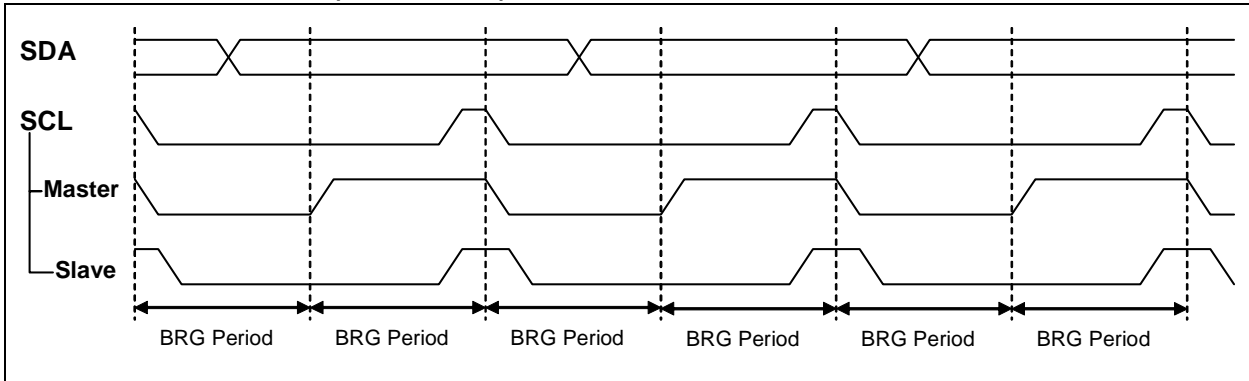
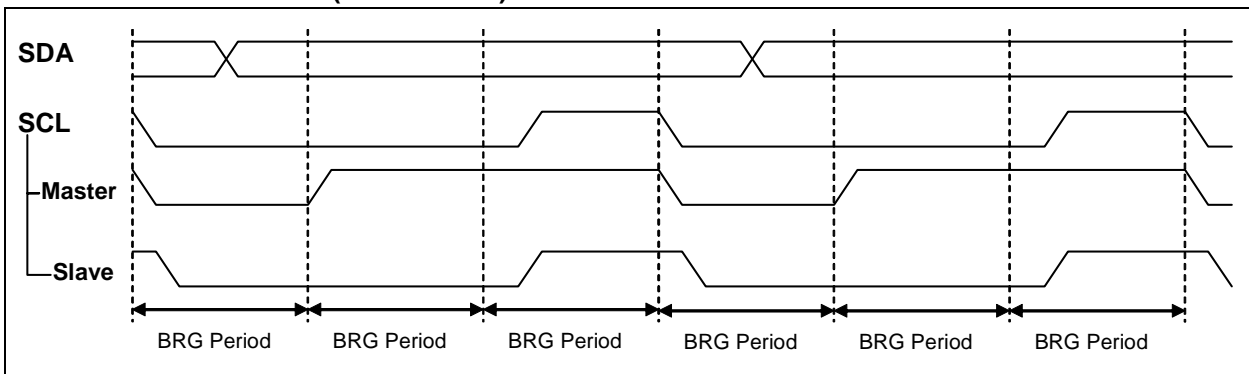
The current implementation does not ensure accurate SCL high time. During clock stretch, the MSSP device will erroneously continue running the BRG counter. At the end of the clock stretch, the BRG counter continues to count down for the

remainder of the BRG period, and then the MSSP device will immediately resume transmitting the data.

Figure 3 and Figure 4 illustrate an actual I²C transmission in which the slave has stretched the clock period by holding the SCL line low. Note that the high time of the SCL signal has shortened from the expected time.

Set the communication speed to match the slowest device on the bus. This ensures that no slave device will perform clock stretching.

It is possible to dynamically adjust the communication speed to match the device being addressed by modifying the BRG register. However, the behavior of slower slave devices must be understood and speed adjustments made such that no slave performs clock stretching.
