PIC16(L)F1934/1936/1937 Family Silicon Errata and Data Sheet Clarification

The PIC16(L)F1934/1936/1937 family devices that you have received conform functionally to the current Device Data Sheet (DS41364E), except for the anomalies described in this document.

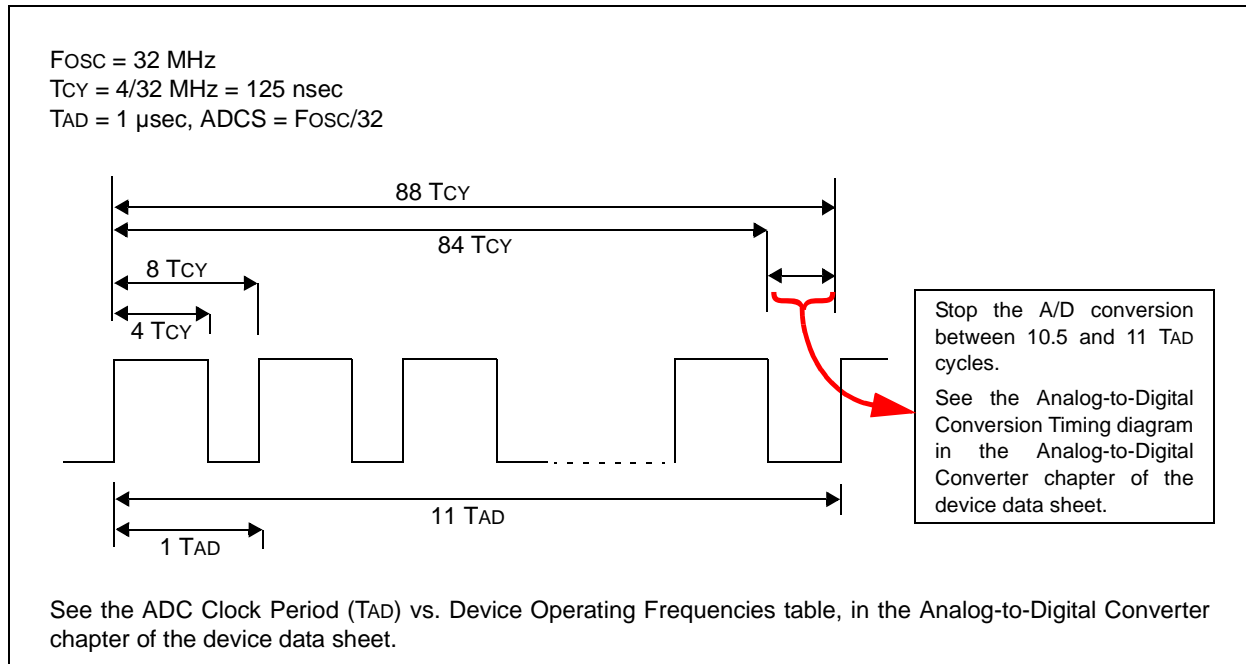
FIGURE 1: INSTRUCTION CYCLE DELAY CALCULATION EXAMPLE

An ADC conversion may not complete under these conditions:

1. When FOSC is greater than 8 MHz and it is the clock source used for the ADC converter.
2. The ADC is operating from its dedicated internal FRC oscillator and the device is not in Sleep mode (any FOSC frequency).

When this occurs, the ADC Interrupt Flag (ADIF) does not get set, the GO/DONE bit does not get cleared, and the conversion result does not get loaded into the ADRESH and ADRESL result registers.

In [Figure 1](#), 88 instruction cycles (TCY) will be required to complete the full conversion. Each TAD cycle consists of 8 TCY periods. A fixed delay is

provided to stop the A/D conversion after 86 instruction cycles and terminate the conversion at the correct time as shown in the figure above.

Method 3: This method is provided if the application cannot use Sleep mode and requires continuous operation at frequencies above 8 MHz. This method requires early termination of an ADC conversion. Provide a fixed time delay in software to stop the A-to-D conversion manually, after all 10 bits are converted, but before the conversion would complete automatically. The conversion is stopped by clearing the GO/DONE bit in software. The GO/DONE bit must be cleared during the last 1/2 TAD cycle, before the conversion would have completed automatically. Refer to [Figure 1](#) for details.

Note: The exact delay time will depend on the TAD divisor (ADCS) selection. The Tcy counts shown in the timing diagram above apply to this example only. Refer to [Table 3](#) for the required delay counts for other configurations.
