OMAP5912
Applications Processor
Silicon Errata

SPRZ209K
December 2003 – Revised December 2007

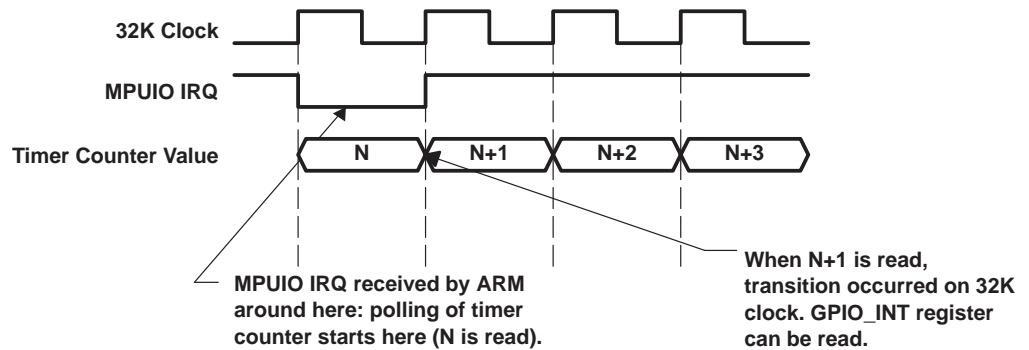
Figure 12. Polling the Timer 32k Timer

Details: The reset of the MPUIO GPIO interrupt is done asynchronously when a GPIO_INT register read occurs. The release of this reset is done synchronously with the ARM_XOR_CK when the 32-kHz clock is high. A read of the GPIO_INT register while the 32-kHz clock is low or transitioning can result in a deadlock to the state machine that will cause all further interrupts subject to the MPUIO pin to be ignored.

Workaround: After receiving the MPUIO GPIO_INT, the MPU should observe the 32-kHz clock and then read the GPIO_INT register only just after a rising edge on the 32-kHz clock. There are different ways to detect a rising edge on the 32-kHz clock:

- Poll the timer 32k counter until there is an increment (see Figure 12, which describes the procedure)

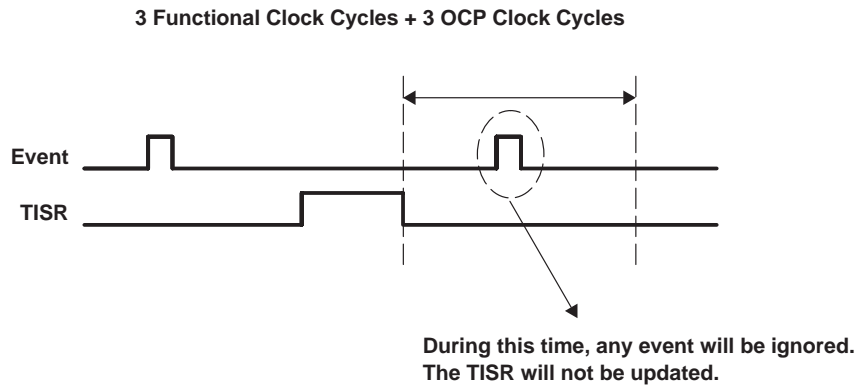
Figure 17. DM Timer Event Ignored Window

After the interrupt gets acknowledged by the TISR and after 3 functional clock cycles + 3 OCP clock cycles, any event of the same type other than the one initially processed, will be ignored, and the corresponding interrupt will be not generated (see Figure 17).

This problem does not occur if the event has a different type: it will be kept in the TISR.

Workaround: There is no workaround.
