# THE DATASHEET OF OMAP5912ZZG

**OMAP5912**  
**Applications Processor**  
**Silicon Errata**

SPRZ209K  
December 2003 – Revised December 2007

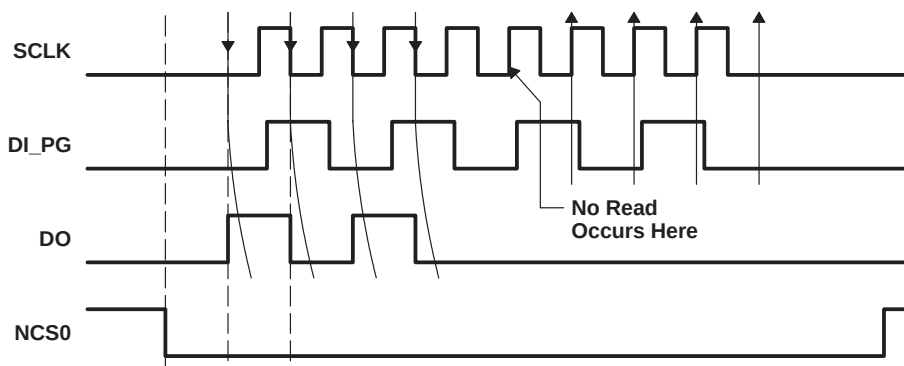
**Advisory  
UWIRE\_1***MICROWIRE Interface RX Data Failures Possible*

**Figure 6. Write (4 Bits) on Falling/Read (4 Bits) on Rising (TX = 0xA, RX and 0xF = 0xA)**

**Workaround:**

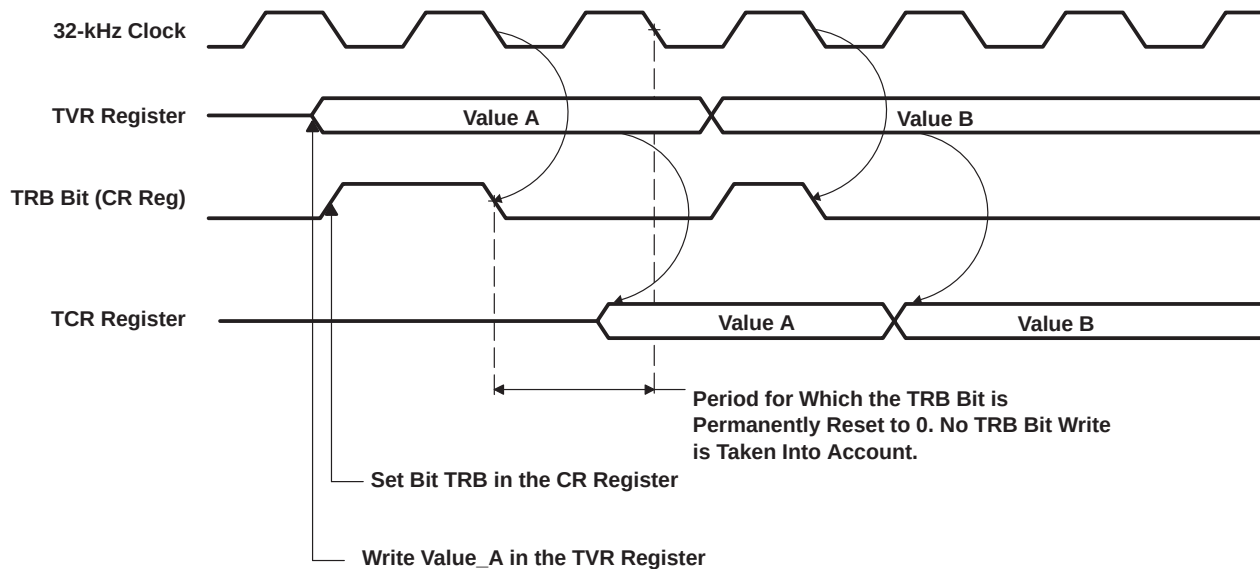
However (see Figure 11), the TRB bit is reset to zero by the falling edge of 32-kHz clock only after a maximum of  $1.5 \times 32\text{-kHz}$  clock period (or minimum  $0.5 \times 32\text{-kHz}$  clock period) after the TRB bit is set. The TCR register is loaded after a maximum of  $2 \times 32\text{-kHz}$  clock periods (or minimum of  $1 \times 32\text{-kHz}$  clock period) on the rising edge of the 32-kHz clock. After the TRB is reset, there is a one 32-kHz clock period where a new TRB setting will not be taken into account by the module. If the user programs the TVR and updates the TRB bit within this 32-kHz clock period, the new TVR will not be loaded correctly into the TCR.

**Figure 11. TRB Timing Diagram****Workaround:**

To load a new value into the TCR, poll the TRB bit. When the TRB is equal to '0' (signaling that the previous value has been loaded), the user has to wait for an additional one 32-kHz clock period, before loading a new value in the TVR and setting the TRB bit to '1'.

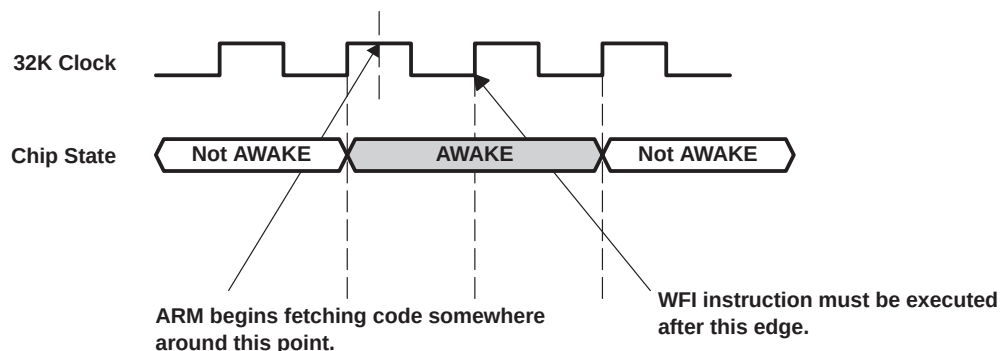
**Details:** When the system goes out of deep or big sleep, at least one 32K clock rising edge must occur before the WFI instruction is executed again. If this does not occur, the ULPD will stay in the awake state, and OMAP5912 will remain in idle mode. This will cause the system to hang. The only way to restore the system is to perform power-on reset or MPU reset.

**Figure 15. Minimum AWAKE Window Needed for Proper Operation**

**Workaround:** The Minimum AWAKE window is needed for proper operation. Software needs to make sure that one 32K clock rising edge occurs between wake up of the device and next WFI instruction execution. This can be done by monitoring 32K counter value.

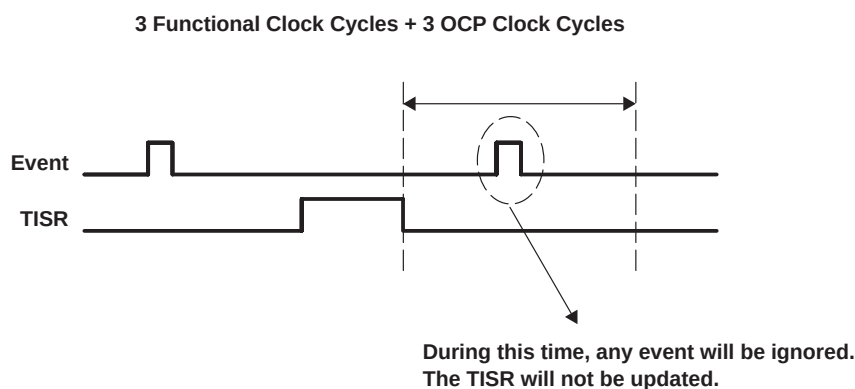
After the interrupt gets acknowledged by the TISR and after 3 functional clock cycles + 3 OCP clock cycles, any event of the same type other than the one initially processed, will be ignored, and the corresponding interrupt will be not generated (see Figure 17).

**Figure 17. DM Timer Event Ignored Window**

**Workaround:** There is no workaround.
