# THE DATASHEET OF AM5718AABCXA

# **AM571x (SR 2.0, 1.0) and AM570x (SR 2.0) Sitara™ Processors**

## **Silicon Errata**

Literature Number: SPRZ436C  
October 2015–Revised February 2017

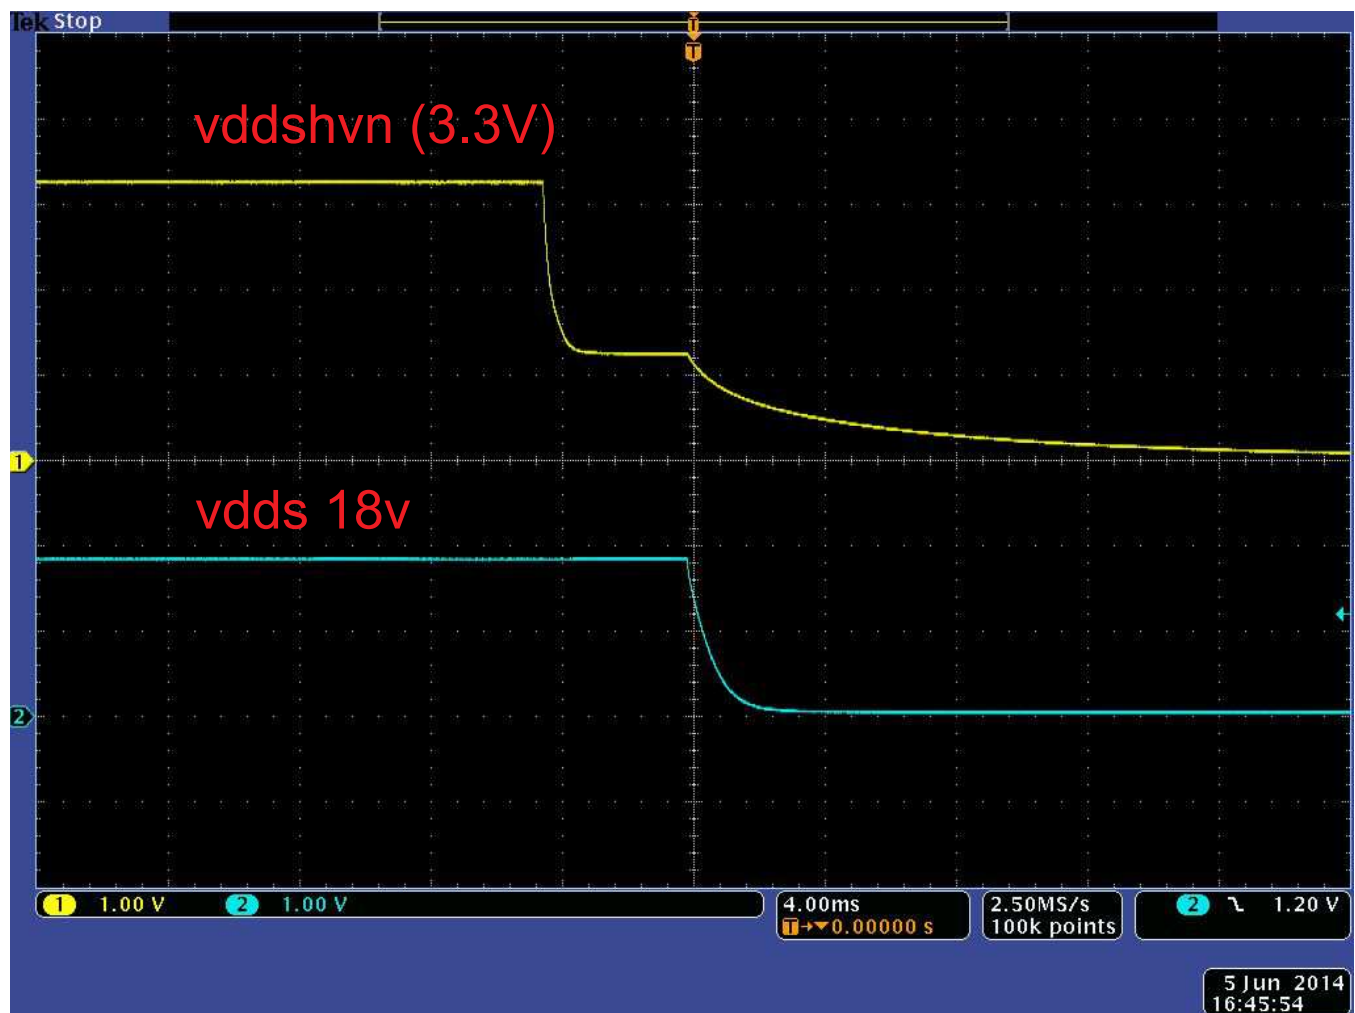
**Figure 4-1. PAB\_RevA**

A subset of the SOC's LVC MOS IOs (refer to DM for details) have a pull-up resistor that is active by default, including during reset and power-down. The SOC's IOs that have internal or external pull-ups will stay at Plateau Level (<1.5V) during the power-down. If other ICs on the board that are interfaced to the SOC's LVC MOS signals use a separate supply then it's possible that the other IC's signals can be pulled to the Plateau Level while its power supply is off.

The root cause of the plateau is related to the LVC MOS IO buffer Dual Voltage detection circuitry. The LVC MOS Dual Voltage IO includes voltage comparator circuitry to determine if the IO is in 3.3V mode or 1.8V mode. During powerdown of vddshvn domains, a current path in the internal bias transistors results in the vddshvn rail being held to an intermediate voltage level (<1.5 V). This path can consume at most 500 uA per IO - worst case estimate is ~150 mA (based on 280 IOs) from the vdds18v supply

during power down. This path is not a reliability concern for the device.

In general, TI recommends using the same supply source for connected components. E.g., a single LDO should drive vddshvn and the related 3.3V external components.
