dsPIC33FJ06GS001/101A/102A/202A and dsPIC33FJ09GS302 Family Silicon Errata and Data Sheet Clarification

The dsPIC33FJ06GS001/101A/102A/202A and dsPIC33FJ09GS302 family devices that you have received conform functionally to the current Device Data Sheet (DS75018C), except for the anomalies described in this document.

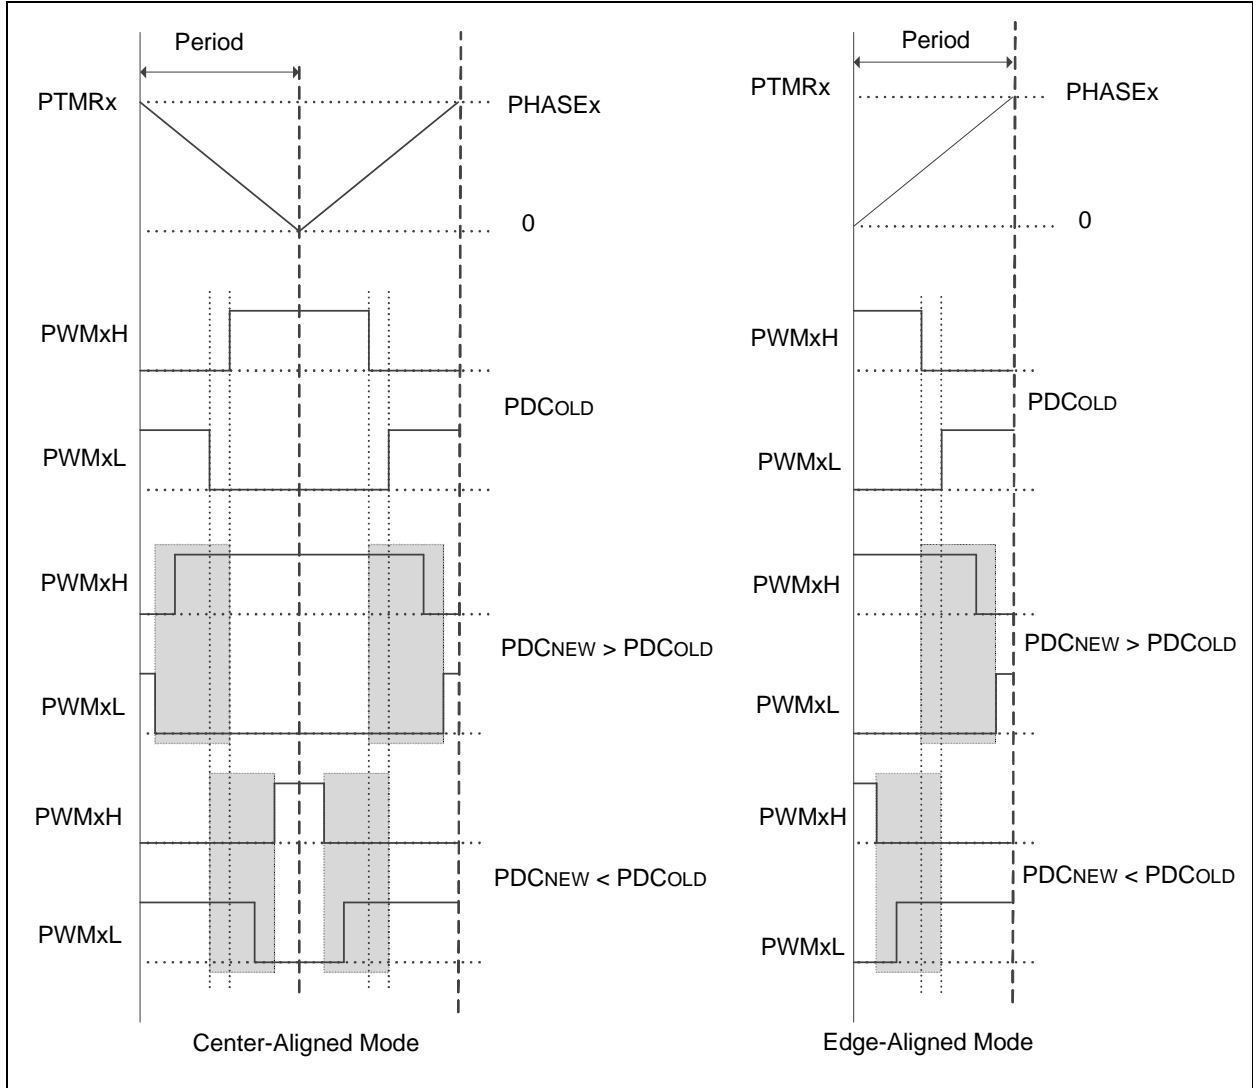
FIGURE 1: TIMING DIAGRAMS FOR CENTER-ALIGNED AND EDGE-ALIGNED MODES

The PWMx generator may not assert dead time on the edges of transitions. This has been observed when all of the following conditions are present:

- The PWMx generator is configured to operate in Complementary mode with the independent time base or master time base;
- Immediate update is enabled; and
- The value in the PDCx register is updated in such a manner that the PWMxH and PWMxL outputs make an immediate transition.

The current duty cycle, PDCOLD, newly calculated duty cycle, PDCNEW, and the point at which the write to the Duty Cycle register occurs within the PWMx time base, will determine if the PWMxH and PWMxL outputs make an immediate transition. PWMxH and PWMxL outputs make an immediate transition if the Duty Cycle register is written with a new value, PDCNEW, at a point of time when the PWMx time base is counting a value that is in between PDCNEW and PDCOLD. Additionally, writing to the Duty Cycle register close to the instant of time where dead time is being applied may result in reduced dead time, effective on the PWMxH and PWMxL transition edges.

In [Figure 1](#) (following page), if the duty cycle write occurred in the shaded box, then PWMxH and PWMxL will make an immediate transition without dead time.

None. However, in most applications the duty cycle update timing can be controlled using the TRIGx trigger or Special Event Trigger such that the above mentioned conditions are avoided altogether.

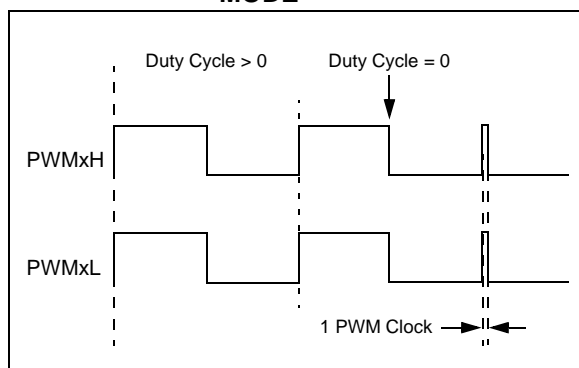
FIGURE 2: ISSUE EXAMPLE FOR REDUNDANT OUTPUT MODE

In Redundant Output mode (IOCONx<11:10> = 01) and Push-Pull Output mode (IOCONx<11:10> = 10) with the Immediate Update Enable bit (PWMCONx<0> = 0) disabled, when the Duty Cycle register is updated from a non-zero value to zero, a glitch pulse of a width equal to 1 PWM clock will appear at the next PWM period boundary, as shown in Figure 2 (for the Redundant Output mode). The Duty Cycle register refers to the PDCx register if PWMCONx<8> = 0 or the MDC register if PWMCONx<8> = 1.

If the application requires a zero duty cycle output, there are two possible work around methods:

1. Use the PWM override feature to override the PWM output to a low state instead of writing to the Duty Cycle register. In order to switch back to a non-zero duty cycle output, turn off the PWM override. The override-on and override-off events must be timed close to the PWM period boundary if the IOCONx register has been configured with IOCONx<0> = 0 (i.e., output overrides through the OVRDAT<1:0> bits occur on the next CPU clock boundary).
2. Enable the Immediate Update Enable bit (PWMCONx<0> = 1) while configuring the PWMx module (i.e., before enabling the PWMx module, PTCON<15> = 1). With the Immediate Update enabled, writes to the Duty Cycle register can have an immediate effect on the PWM output. Therefore, the duty cycle write operations must be timed close to the PWM period boundary in order to avoid distortions in the PWM output.

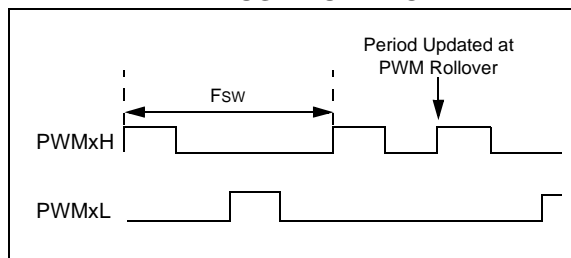
FIGURE 3: ISSUE EXAMPLE IN PUSH-PULL MODE

When the PWM module is configured for Push-Pull mode (IOCONx<11:10> = 10) with the Enable Immediate Period Updates bit enabled (PTCON<10> = 1), a write to the Period register that coincides with the period rollover event may cause the push-pull output logic to produce back-to-back pulses on the PWMx output pins (Figure 3).

Use either the PWMx Special Event Compare (SEVTCMP) or PWMx Primary Trigger Compare Value (TRIGx) to generate a PWM Interrupt Service Routine (ISR) near the start of the PWM cycle. This ISR will ensure that period writes do not occur near the PWM period rollover event.

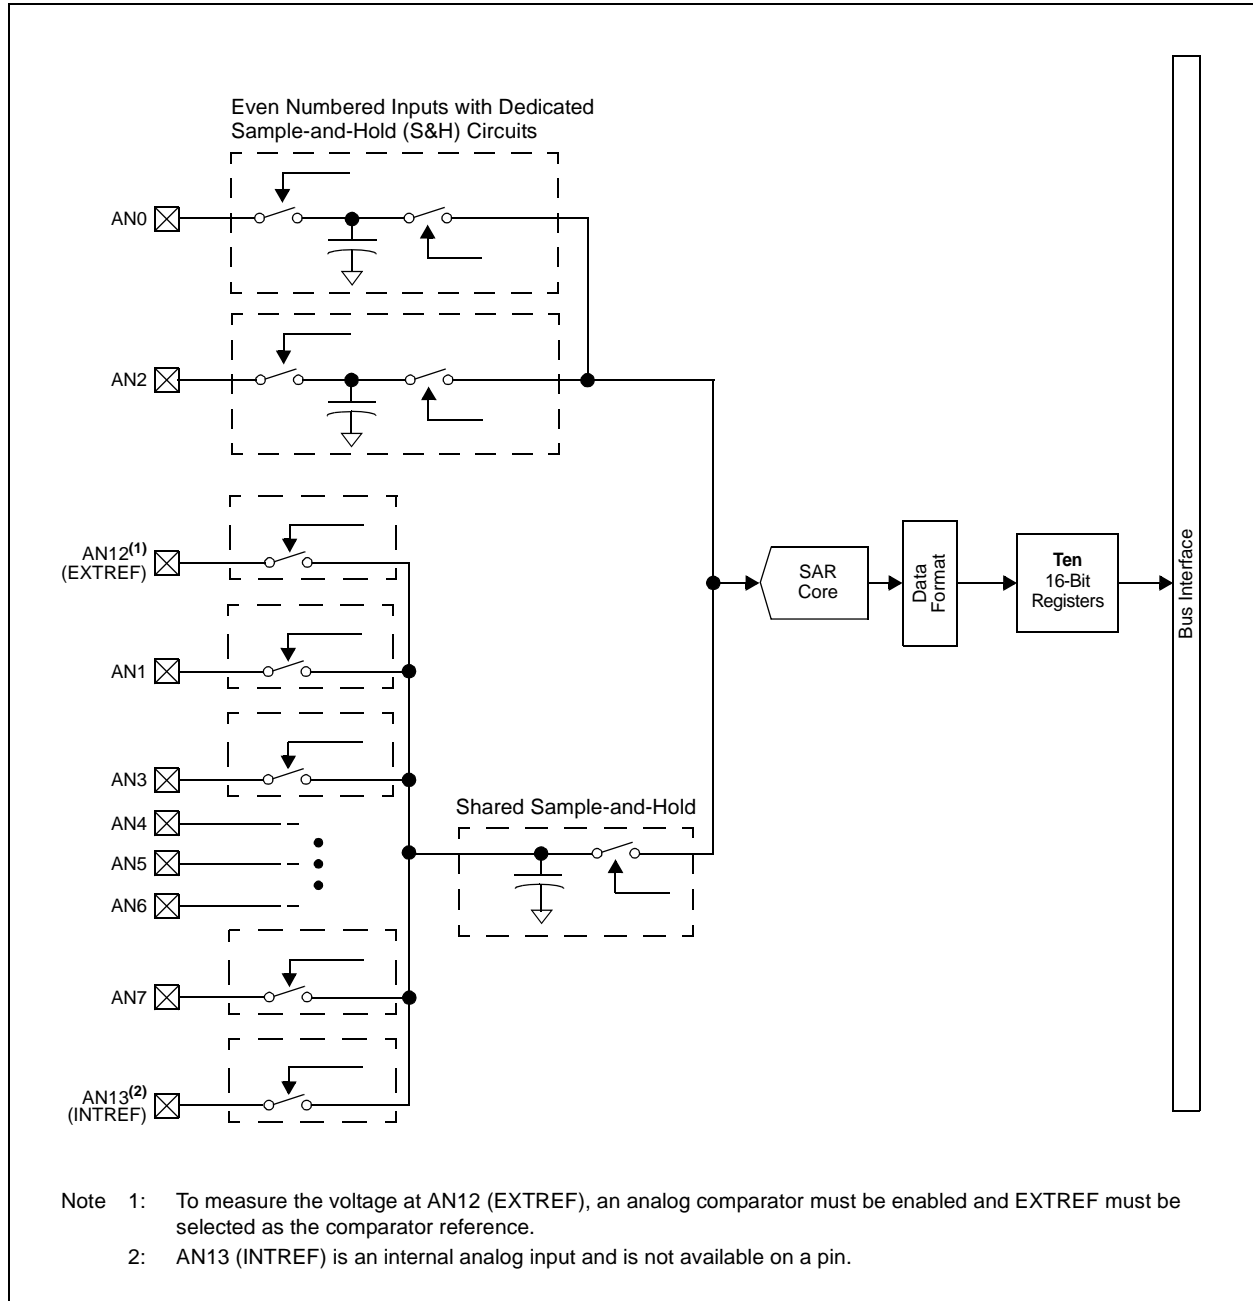
FIGURE 19-5: ADC BLOCK DIAGRAM FOR THE dsPIC33FJ09GS302 DEVICE

In [Figure 19-5](#), the number of output registers has been changed from eight to ten. The changes are shown in bold below:
