PIC16(L)F1782/1783 Family Silicon Errata and Data Sheet Clarification

The PIC16(L)F1782/1783 family devices that you have received conform functionally to the current Device Data Sheet (DS41579D), except for the anomalies described in this document.

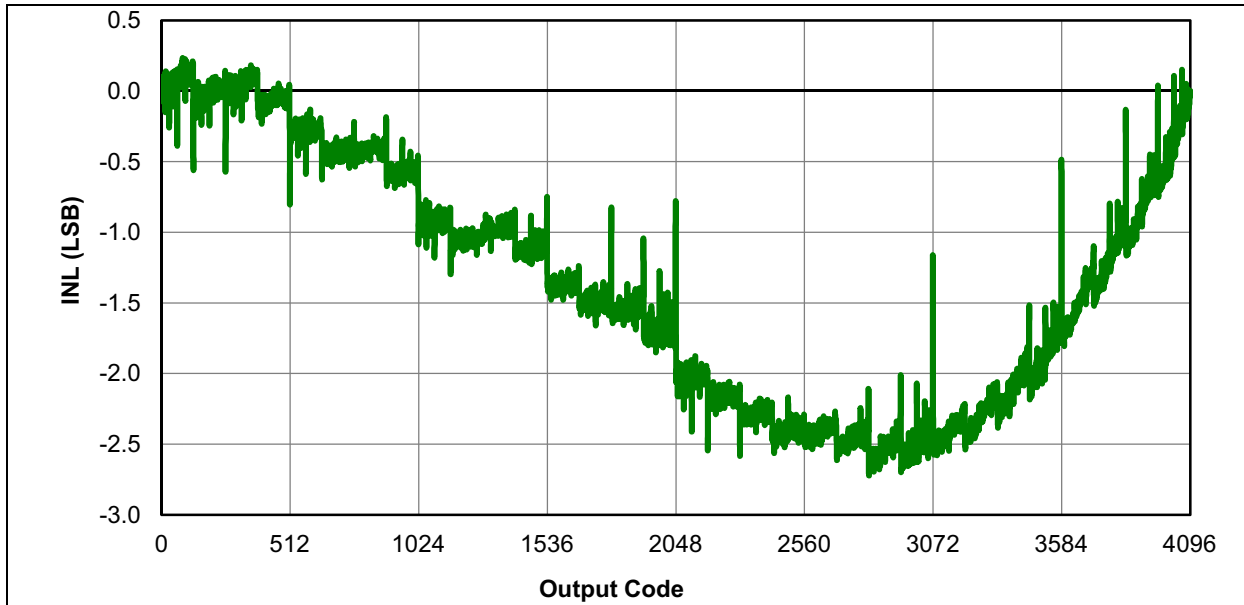
FIGURE 1: ADC 12-BIT MODE, SINGLE-ENDED INL, $V_{DD} = 3.0V$, $T_{AD} = 4 \mu s$, $25^{\circ}C$, TYPICAL MEASURED VALUES

The ADC linearity is ± 4 LSB for the 12-bit mode. Below are typical INL graphs in 12-bit mode (See [Figure 1](#) and [Figure 2](#)).

None.
