PIC24FJ256GB110 Family Silicon Errata and Data Sheet Clarification

The PIC24FJ256GB110 family devices that you have received conform functionally to the current Device Data Sheet (DS39897C), except for the anomalies described in this document.

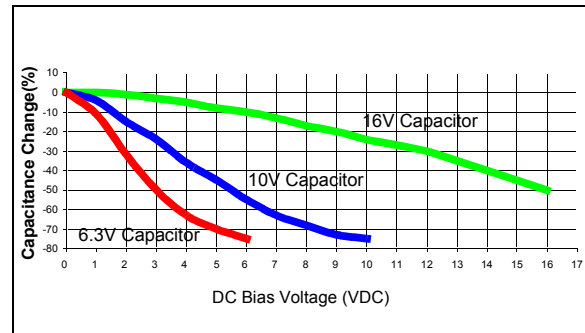
FIGURE 2-4 DC BIAS VOLTAGE vs. CAPACITANCE CHARACTERISTICS

A typical DC bias voltage vs. capacitance graph for 16V, 10V and 6.3V rated capacitors is shown in Figure 2-4.

When selecting a ceramic capacitor to be used with the internal voltage regulator, it is suggested to select a high-voltage rating, so that the operating voltage is a small percentage of the maximum rated capacitor voltage. For example, choose a ceramic capacitor rated at 16V for the 2.5V core voltage. Suggested capacitors are shown in Table 2-1.
