PIC24FJ256GB110 Family Silicon Errata and Data Sheet Clarification

The PIC24FJ256GB110 family devices that you have received conform functionally to the current Device Data Sheet (DS39897C), except for the anomalies described in this document.

The silicon issues discussed in the following pages are for silicon revisions with the Device and Revision IDs listed in [Table 1](#). The silicon issues are summarized in [Table 2](#).

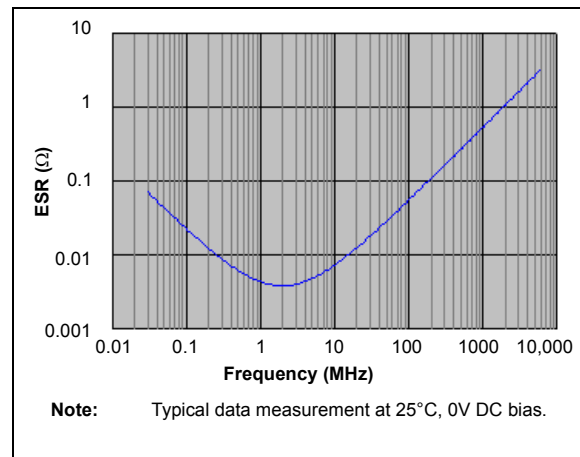
FIGURE 2-3 FREQUENCY vs. ESR PERFORMANCE FOR SUGGESTED VCAP

The placement of this capacitor should be close to VCAP/VDDCORE. It is recommended that the trace length not exceed 0.25 inch (6 mm). Refer to **Section 29.0 “Electrical Characteristics”** for additional information.

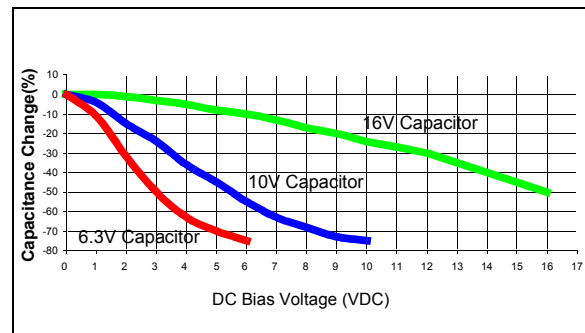
FIGURE 2-4 DC BIAS VOLTAGE vs. CAPACITANCE CHARACTERISTICS

A typical DC bias voltage vs. capacitance graph for 16V, 10V and 6.3V rated capacitors is shown in Figure 2-4.

When selecting a ceramic capacitor to be used with the internal voltage regulator, it is suggested to select a high-voltage rating, so that the operating voltage is a small percentage of the maximum rated capacitor voltage. For example, choose a ceramic capacitor rated at 16V for the 2.5V core voltage. Suggested capacitors are shown in Table 2-1.
