# PIC32MX534/564/664/764

## PIC32MX534/564/664/764 Family Silicon Errata and Data Sheet Clarification

The PIC32MX534/564/664/764 family devices that you have received conform functionally to the current Device Data Sheet (DS60001156H), except for the anomalies described in this document.

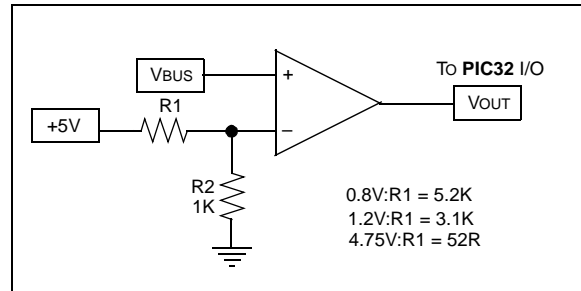
FIGURE 1: EXTERNAL COMPARATOR SCHEMATIC EXAMPLE

When the USB model is configured for OTG operation, it may not recognize all required OTG voltage levels on VBUS pin.

Use external comparator circuit to detect OTG specific voltage levels on VBUS pin.
