TAS5504A Errata

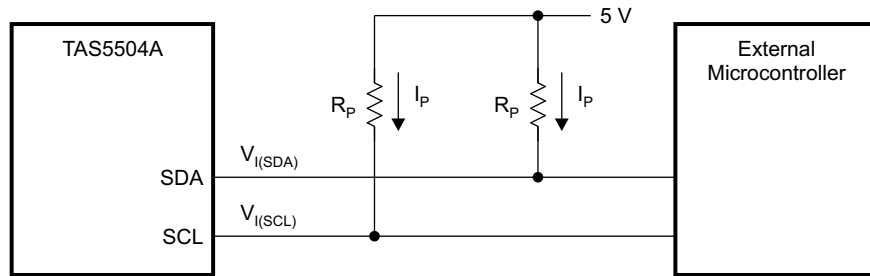
Figure 1. I²C Pullup Circuit (With No Series Resistor)

The I²C specification requires that V_{IH} is $0.7 \times V_{DD} = 3.5$ V when V_{DD} is 5 V. In some 5-V CMOS systems, the normal value for the I²C pullup resistor is 4.7 k Ω . This could cause the voltage not to rise above 3.47 V, which violates the specification. The root cause has been identified as a TAS5504A 5-V tolerant buffer issue.

It is recommended that the I²C pullup resistors, R_p , be 3.3 k Ω (see Figure 1). If a series resistor is in the circuit (see Figure 2), then the series resistors, R_s , should be less than or equal to 300 Ω .

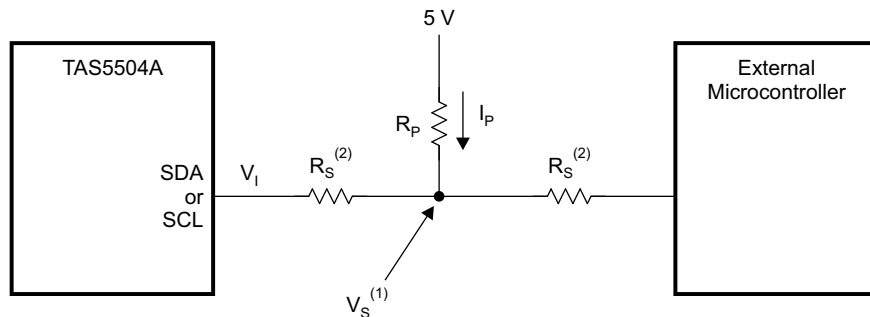
Figure 2. I²C Pullup Circuit (With Series Resistor)

- (1) $V_S = 5 \times R_S / (R_S + R_p)$. When driven low, $V_S \ll V_{IL}$ requirements.
- (2) $R_S \leq 300 \Omega$

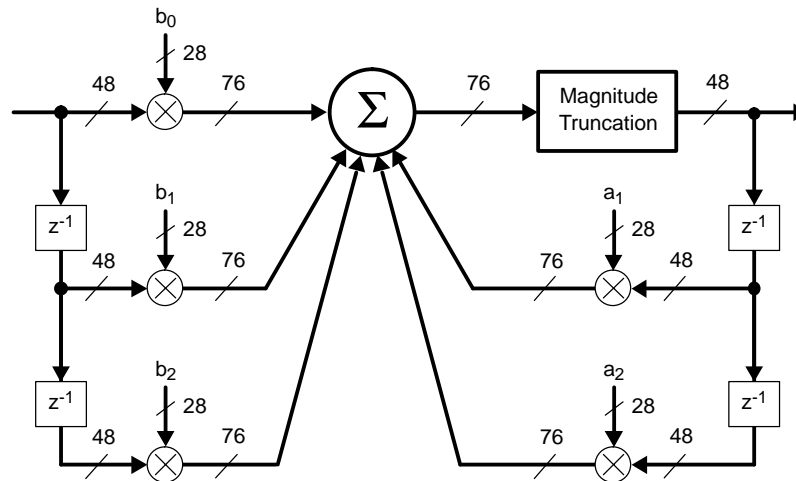
The TAS5504A exhibits a one-sample delay on channels 3 and 4 for sample rates of 32, 44.1, and 48 kHz. The delay occurs in the PWM section.

This time misalignment can impact applications where the TAS5504A is used to provide crossover filtering and bi-amplification, as in powered loudspeakers. The problem that occurs in these cases is that a one-sample time delay in either the high-pass or low-pass path causes an error in the overall crossover frequency response.

The time misalignment can be corrected by using a biquad to provide a one-sample delay for each of the nondelayed PWM channels for the 48-, 44.1-, and 32-kHz sample rates.

1. Set the b_1 biquad coefficients to a gain of 1.
2. Set all of the other biquad coefficients (b_0 , b_2 , a_1 , and a_2) to a gain of 0, as shown in the following diagram and table.
