# PIC32MZ EF FAMILY

## PIC32MZ Embedded Connectivity with Floating Point Unit (EF) Family Silicon Errata and Data Sheet Clarification

The PIC32MZ Embedded Connectivity with Floating Point Unit (EF) family of devices that you have received conform functionally to the current Device Data Sheet (DS60001320), except for the anomalies described in this document.

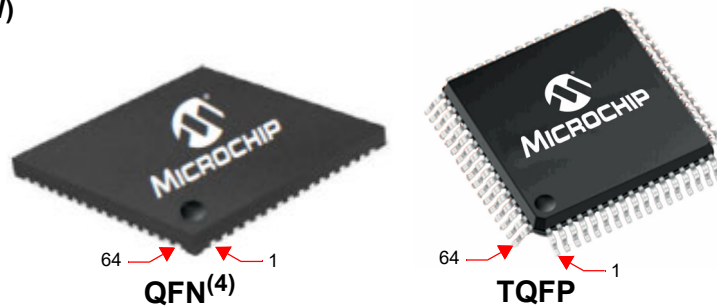
### 64-PIN QFN<sup>(4)</sup> AND TQFP (TOP VIEW)

The following typographic corrections and clarifications are to be noted for the latest version of the device data sheet (DS60001320H):
