# THE DATASHEET OF OMAP5912ZZG

**OMAP5912**  
**Applications Processor**  
**Silicon Errata**

SPRZ209K  
December 2003 – Revised December 2007

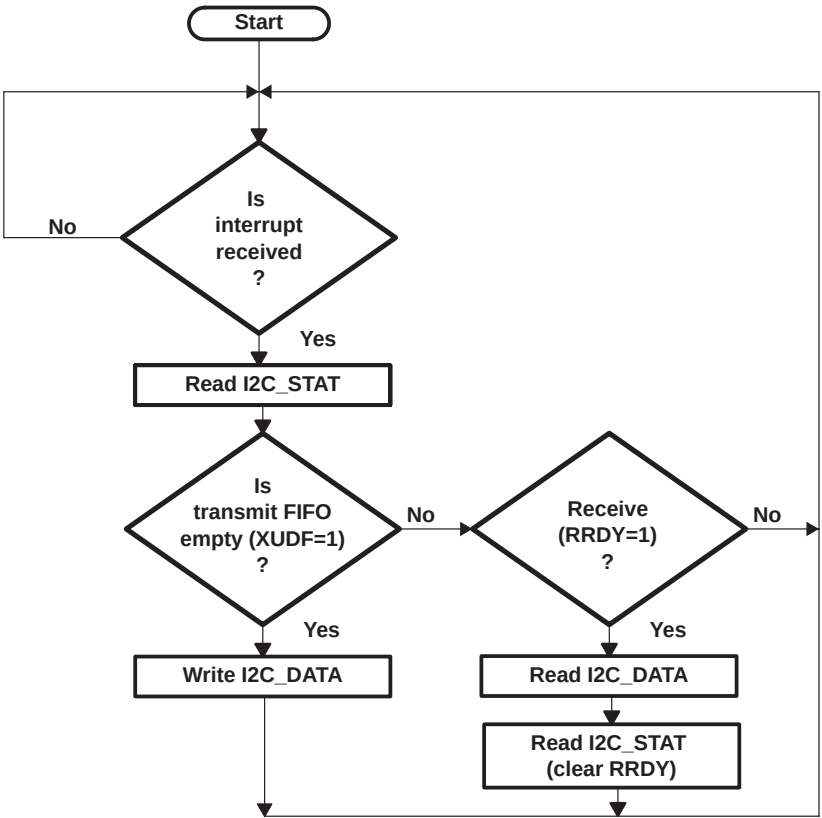
**Figure 10. Slave Transmitter/Receiver Mode Interrupt Flow Diagram**

Figure 9 and Figure 10 show the flowcharts of slave transmit/receive operation in interrupt and polling modes.

This exception will not be fixed in future silicon revisions.
