dsPIC33FJ06GS001/101A/102A/202A and dsPIC33FJ09GS302 Family Silicon Errata and Data Sheet Clarification

The dsPIC33FJ06GS001/101A/102A/202A and dsPIC33FJ09GS302 family devices that you have received conform functionally to the current Device Data Sheet (DS75018C), except for the anomalies described in this document.

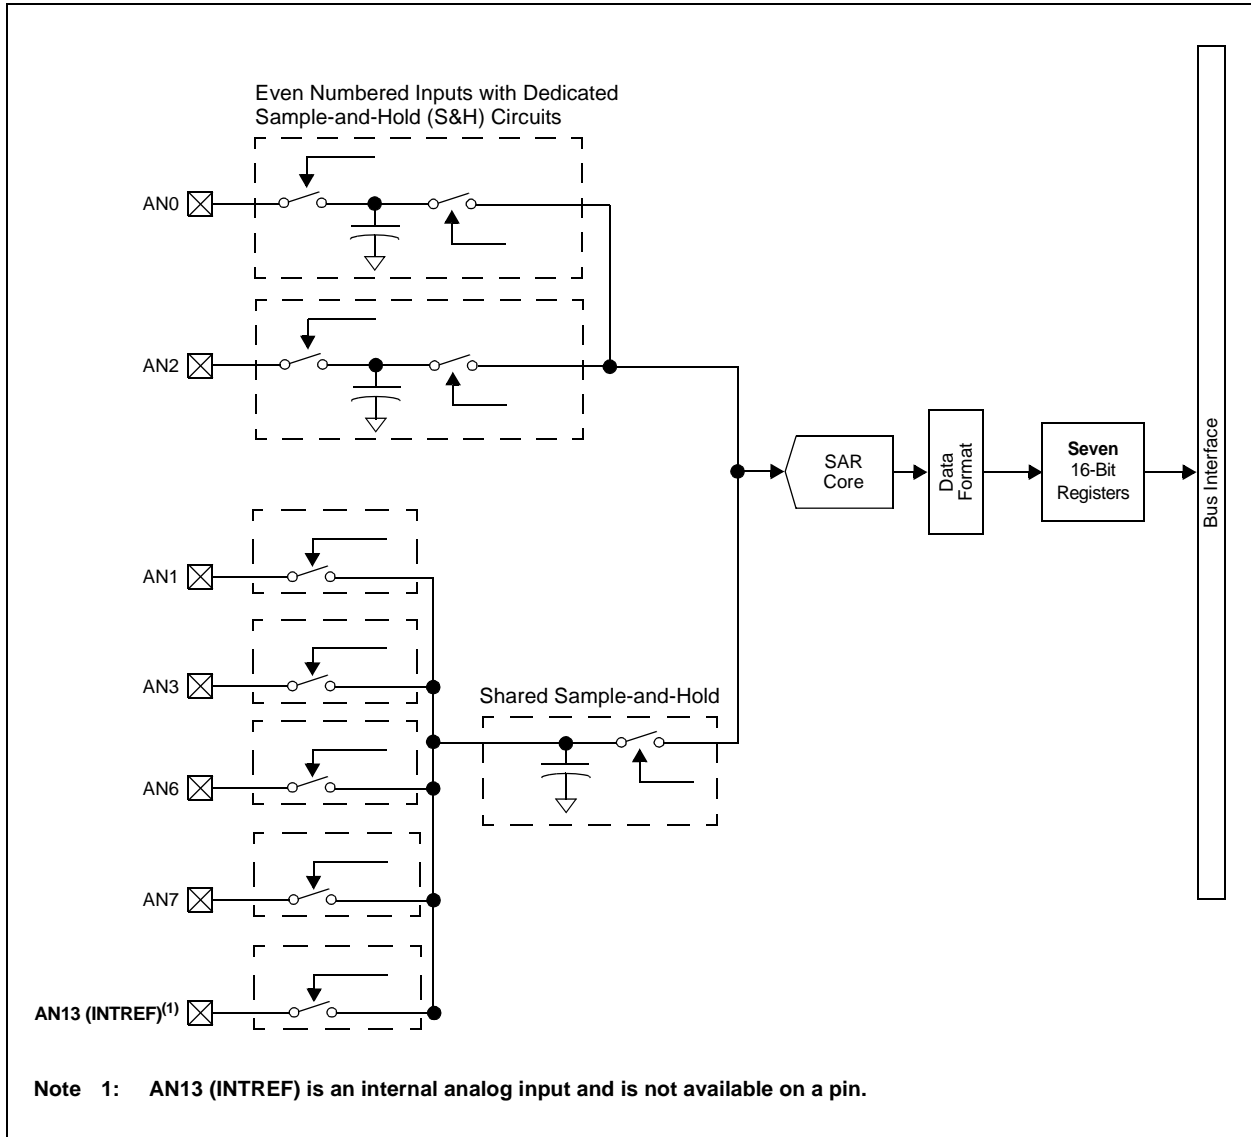
FIGURE 19-2: ADC BLOCK DIAGRAM FOR THE dsPIC33FJ06GS101A DEVICE

In [Figure 19-2](#) and [Figure 19-3](#), AN13 has been added and the number of output registers has been changed from eight to seven.
