**THE DATASHEET OF
GT28F320B3BA100**

**3 Volt Intel[®] Advanced Boot
Block Flash Memory
28F004/400/008/800/
016/160/320/640B3 (x8/x16)**

Specification Update

Order Number: 297948-012

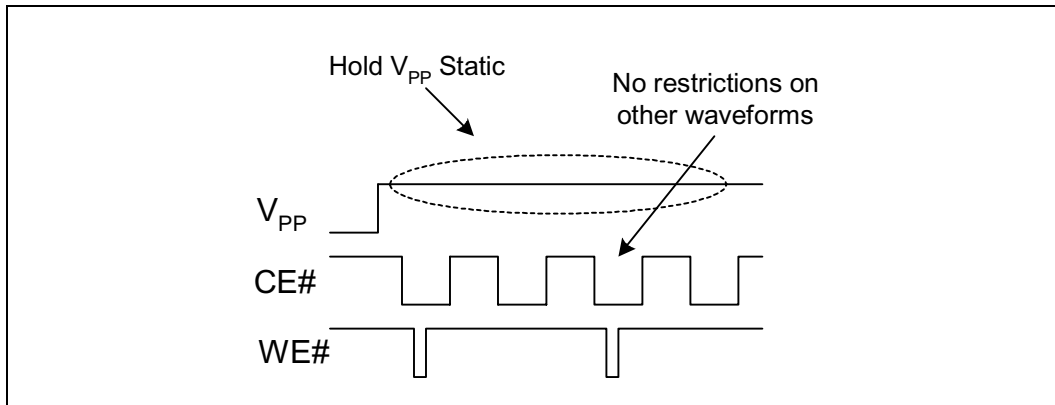
Problem: The 0.18 μ m 28F320B3xC devices can unintentionally reset under certain conditions where V_{PP} toggles.

Implication: When the reset occurs, any command being executed is interrupted and the flash switches to read array mode.

- 1) Tie V_{PP} to V_{CC}
- 2) If the third and fourth digits on the top side FPO mark (third line) are equal or greater than “23”, then V_{CC} may be set from 2.7 V to 3.3 V. V_{CC} must not exceed 3.3 V.
- 3) Set V_{PP} to a static high or static low level as shown here; and
